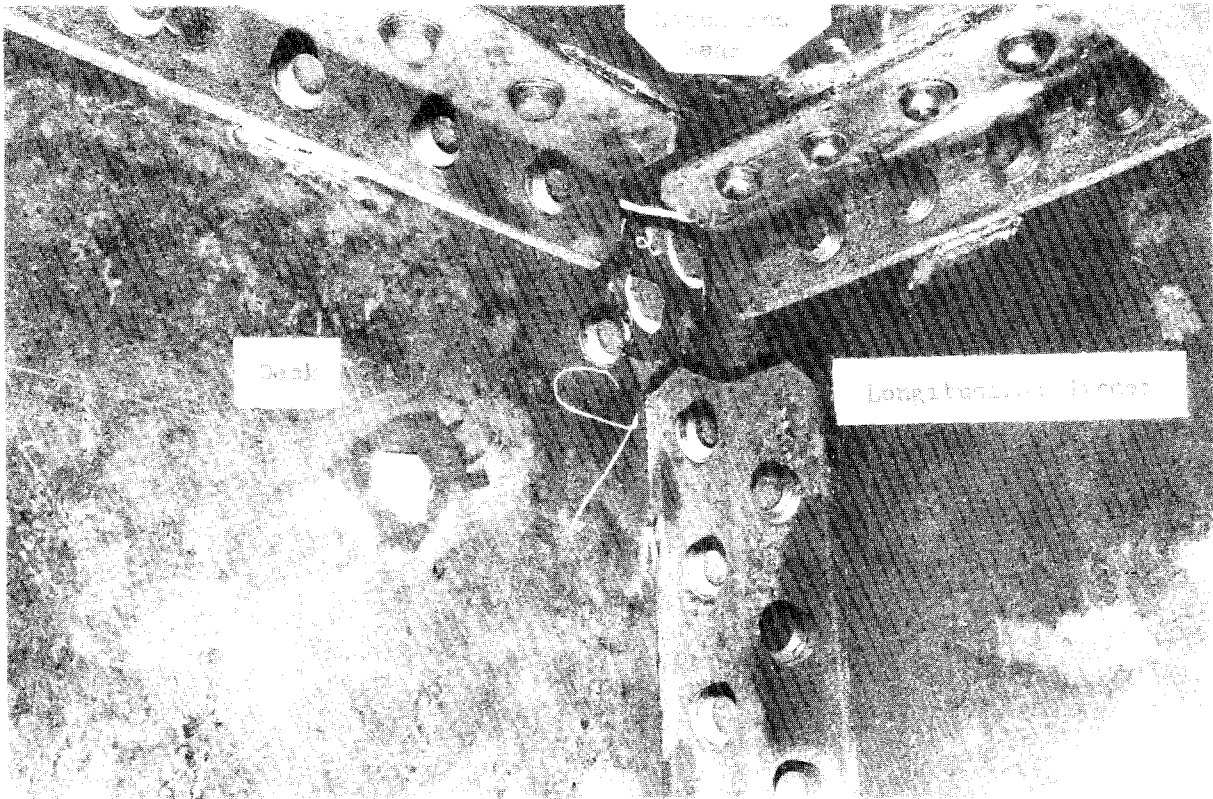
Fracture in deck: Viewed from below deck, outboard,
and fwd. of hatch end beam

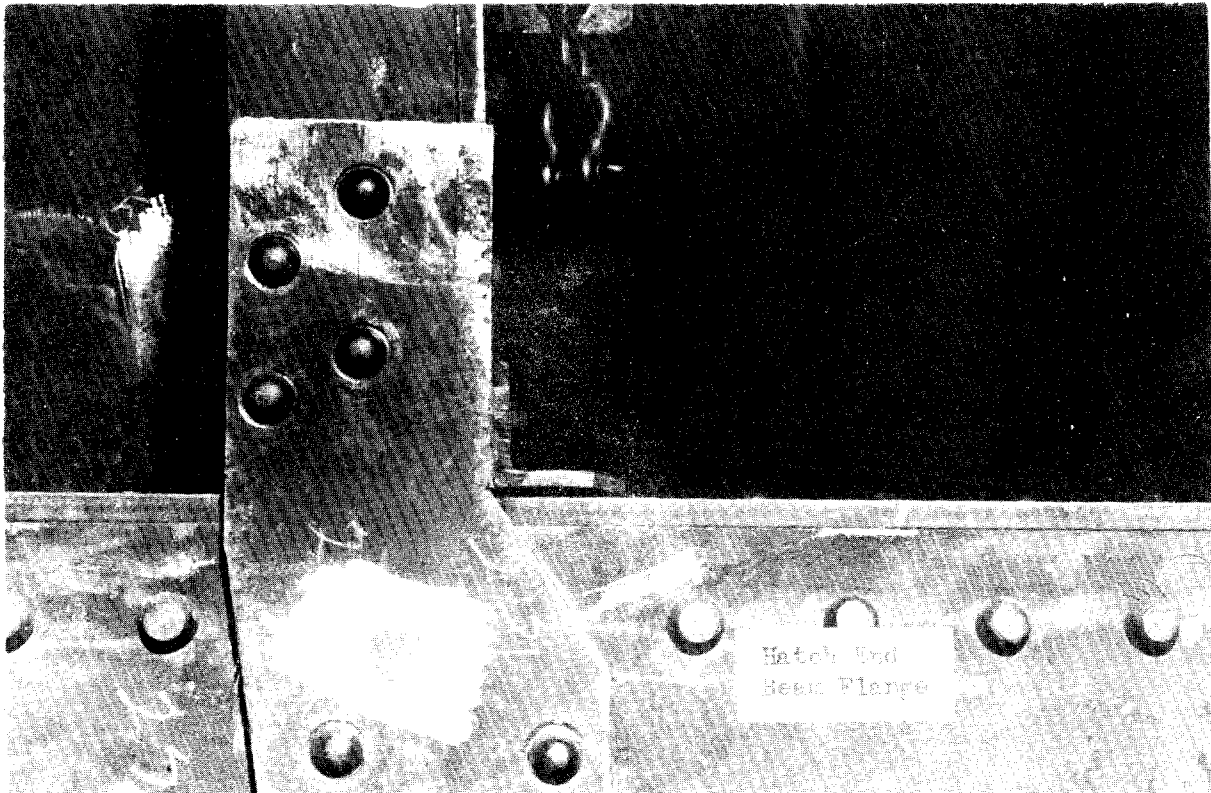
After failure: Close-up of tie-plate
