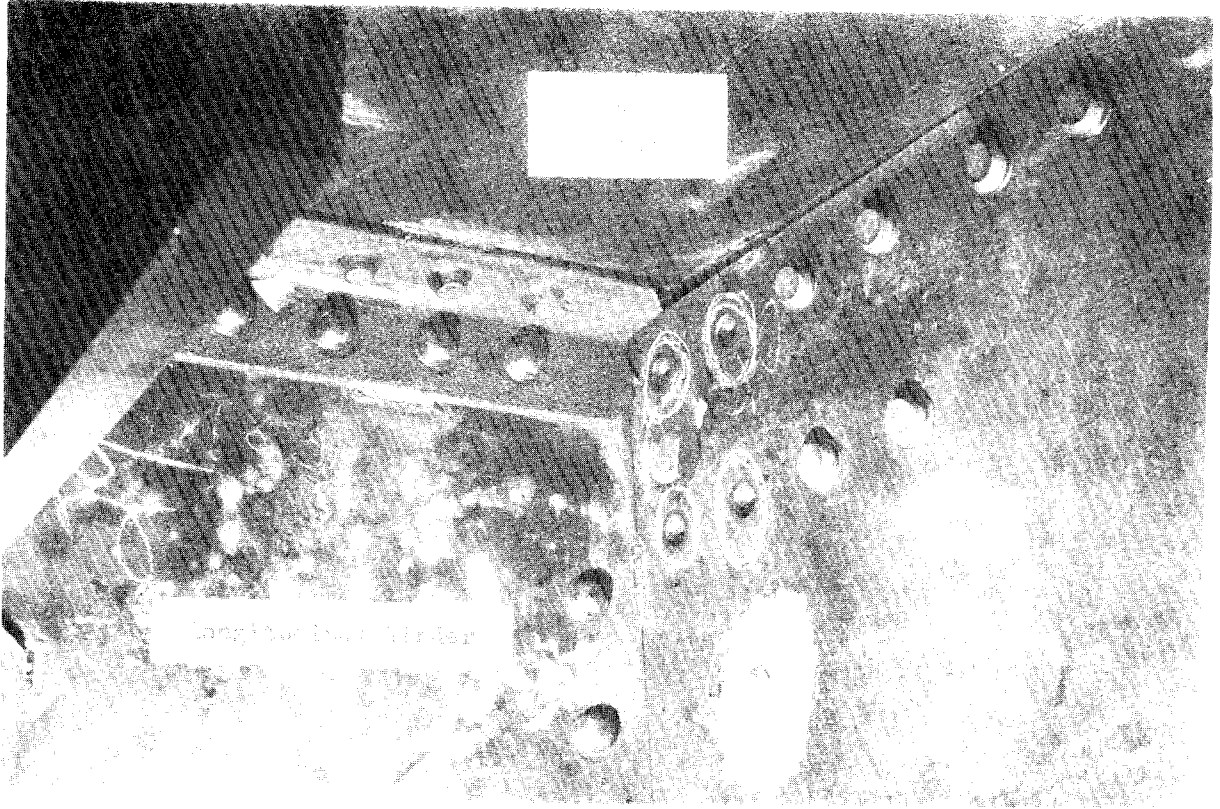
After failure: View from below deck, inboard,  
and fwd. of hatch end beam

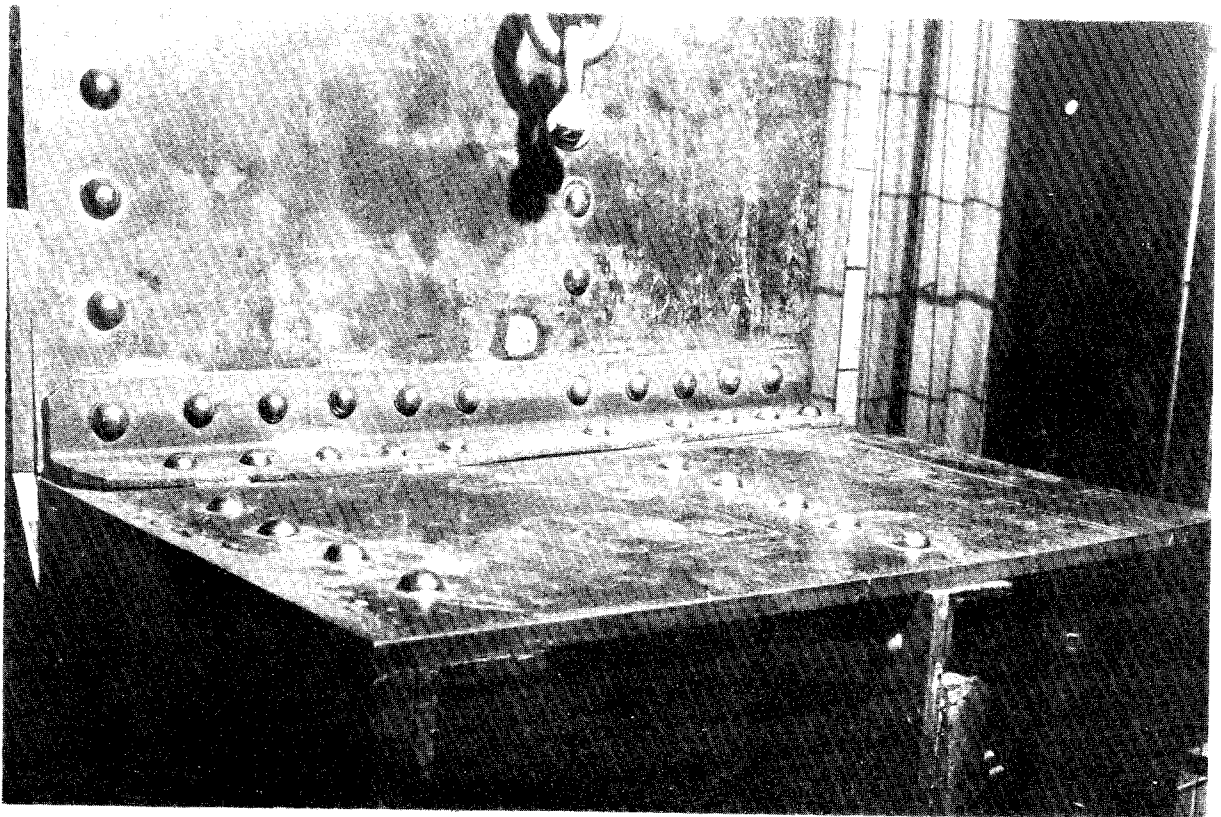
After failure: Corner viewed from inside of hatch
