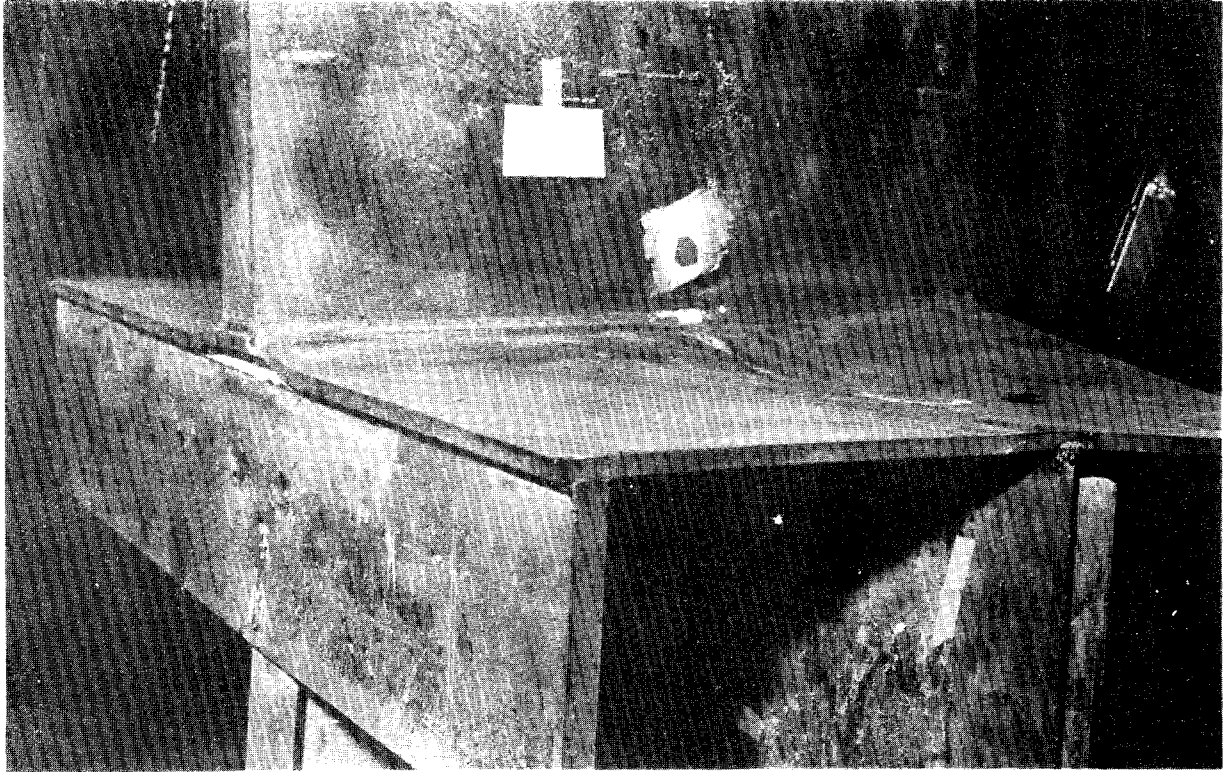
Corner viewed from inside of hatch

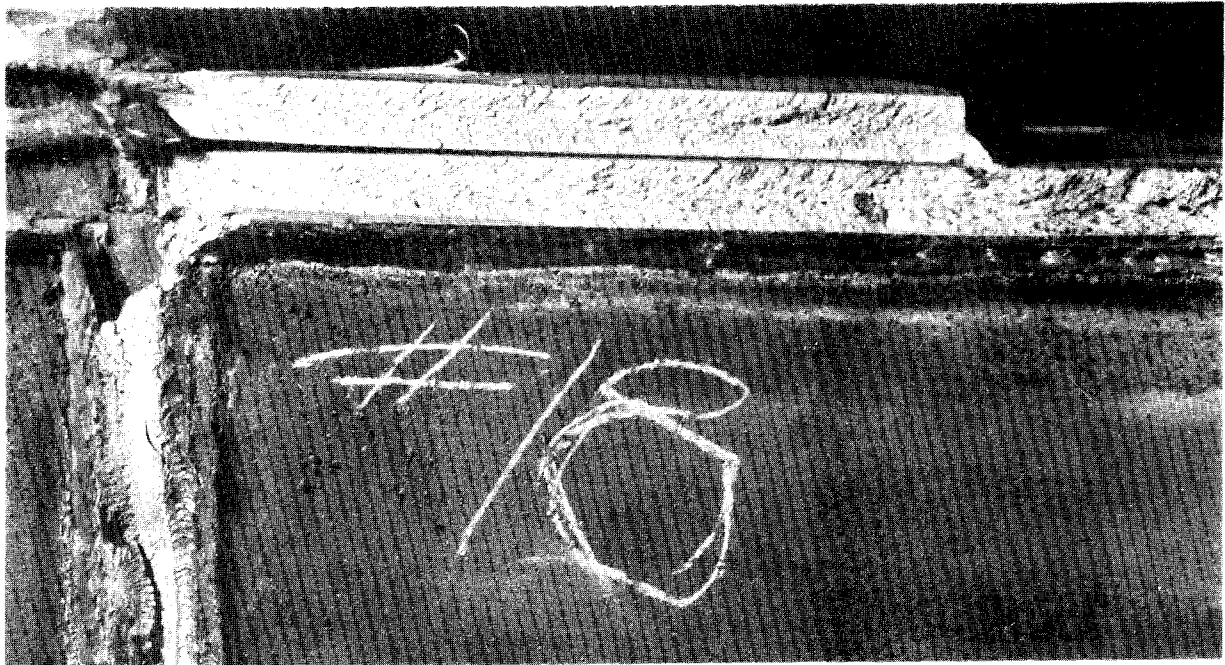
FIG. 22 - SPECIMEN 18

Deck and doubler fracture patterns - looking aft
