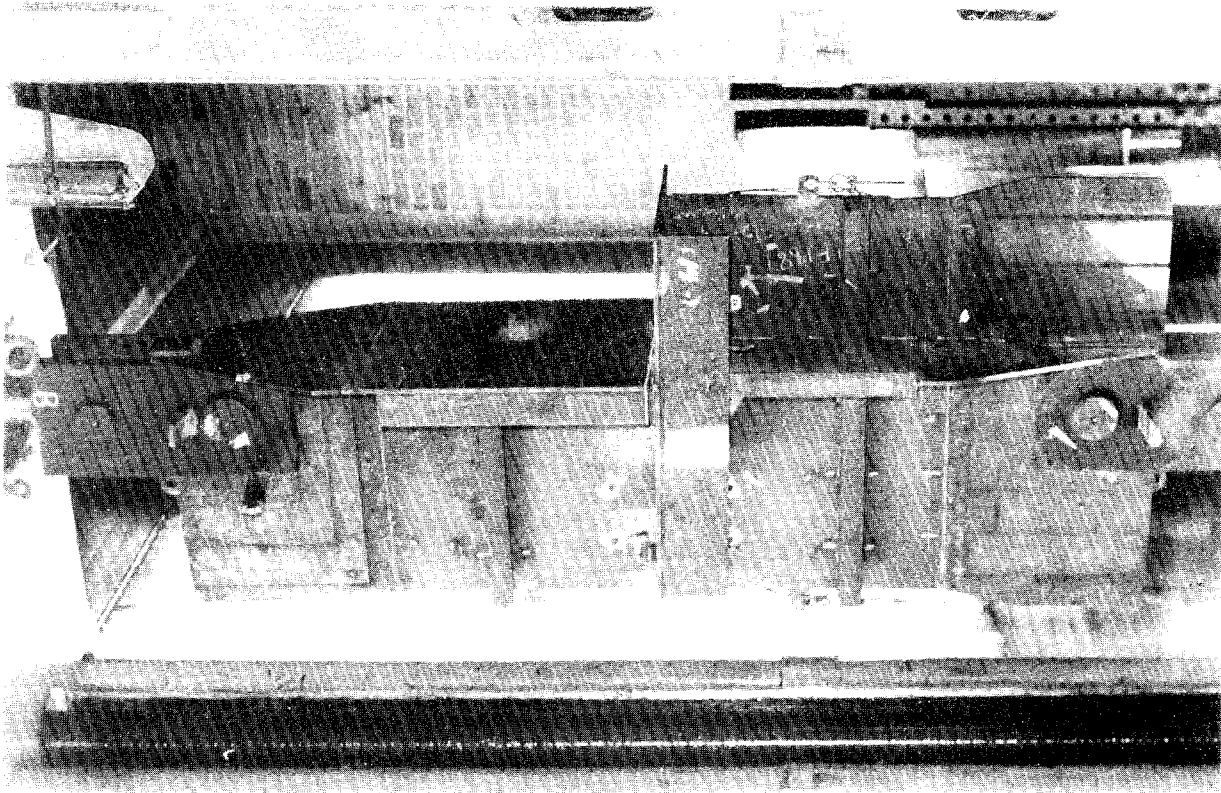
Overall view - below deck

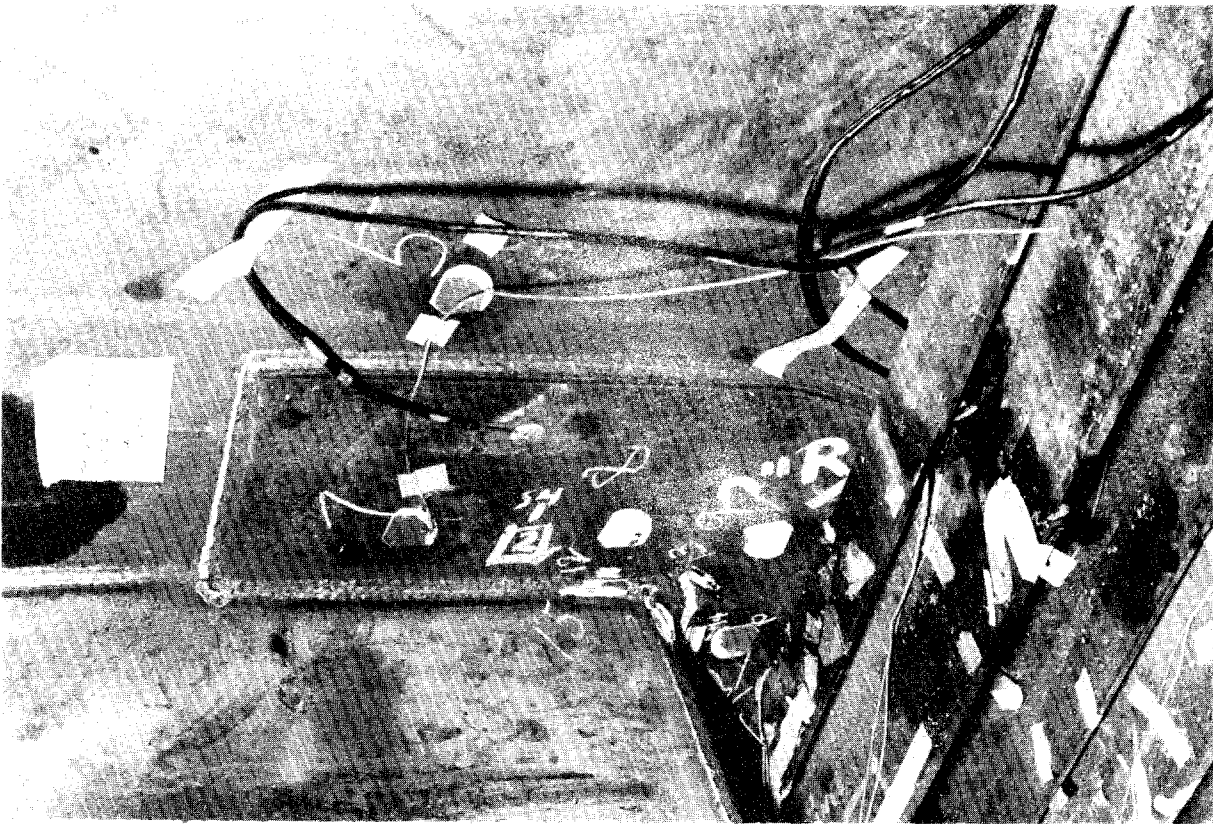
FIG. 8 - SPECIMEN 14

Crack in doubler-deck weld
