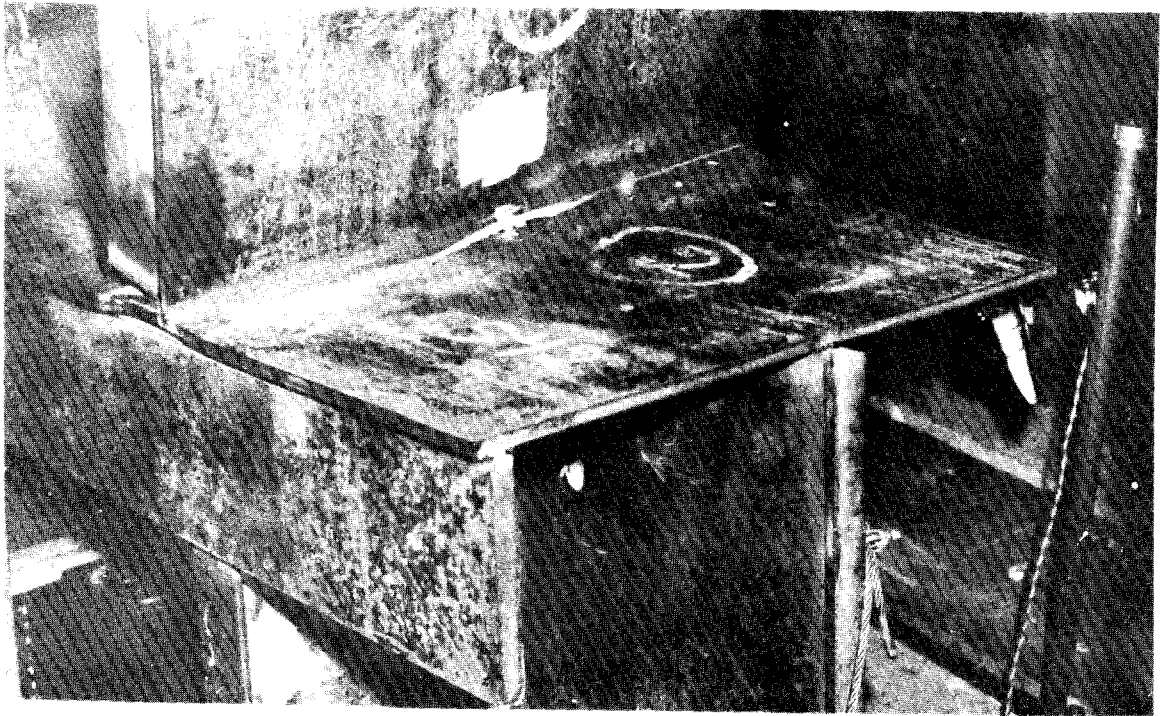
Fracture in corner - viewed from inside of hatch

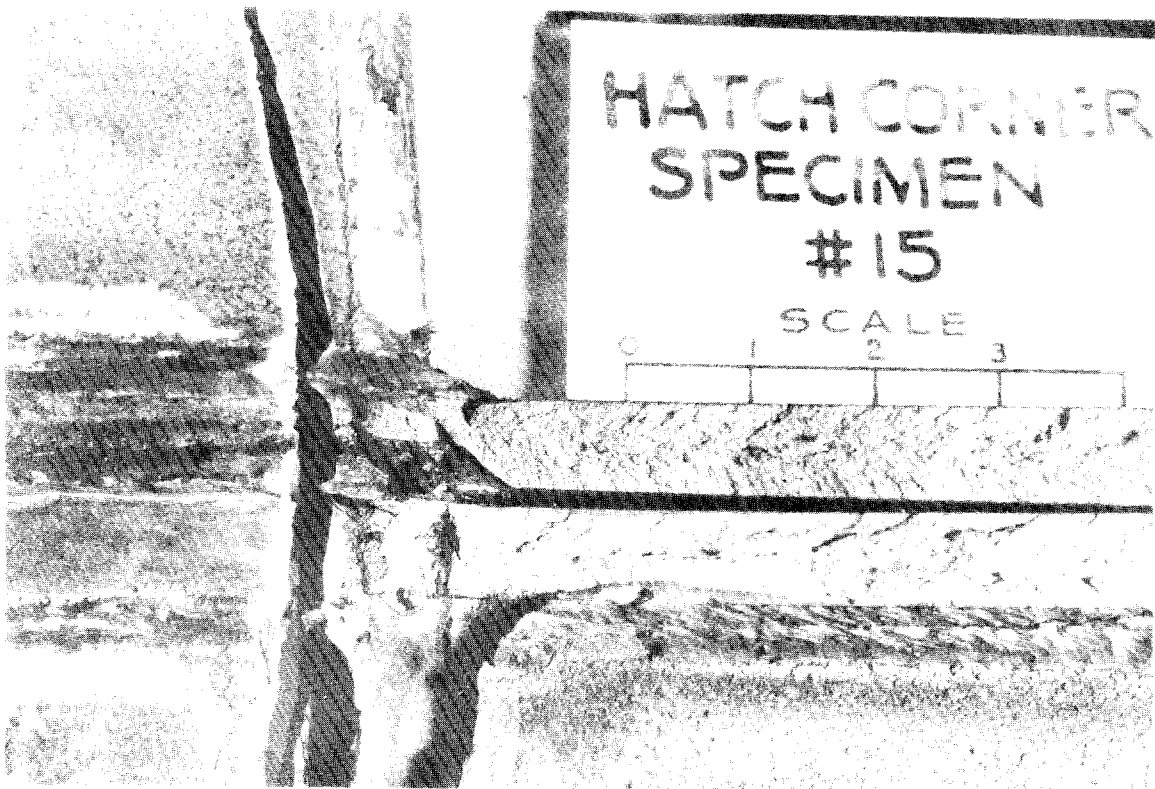
Deck and doubler fracture patterns, looking aft.
