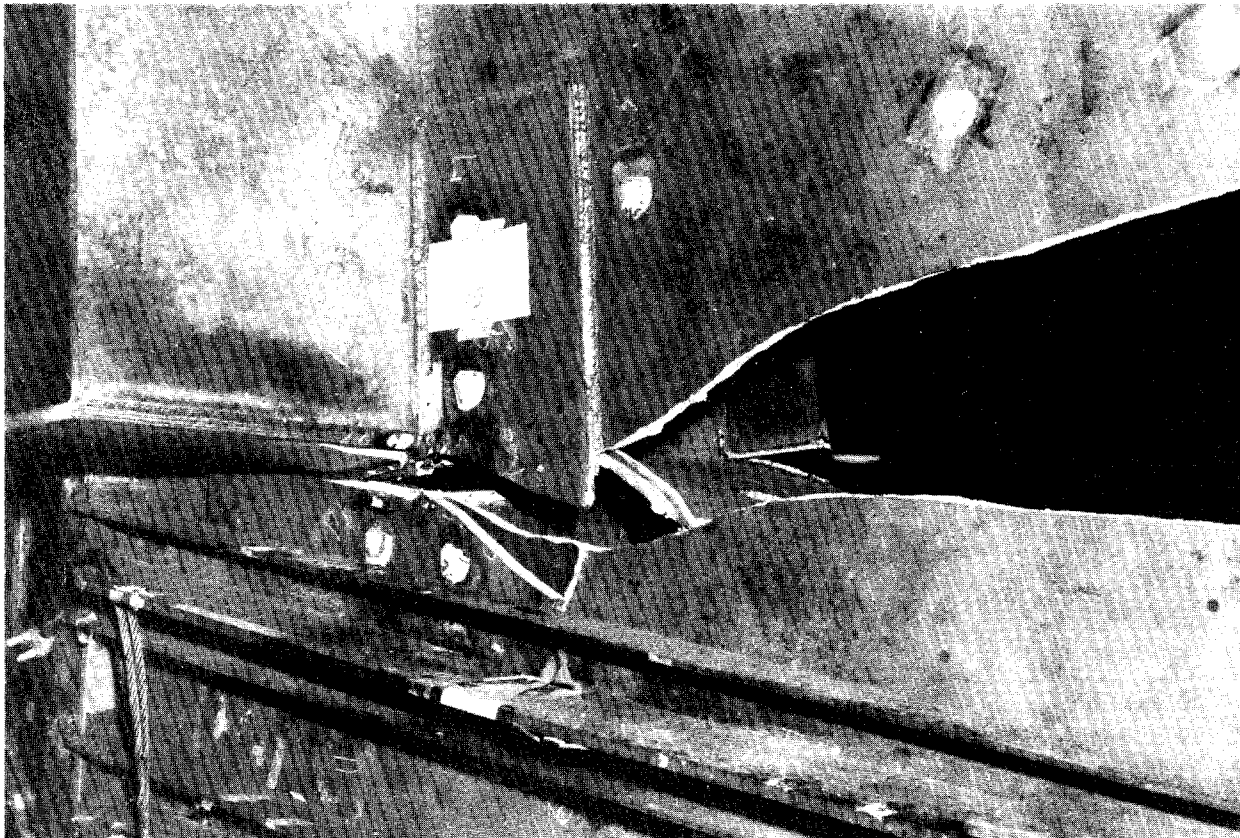
Fractures viewed from above deck

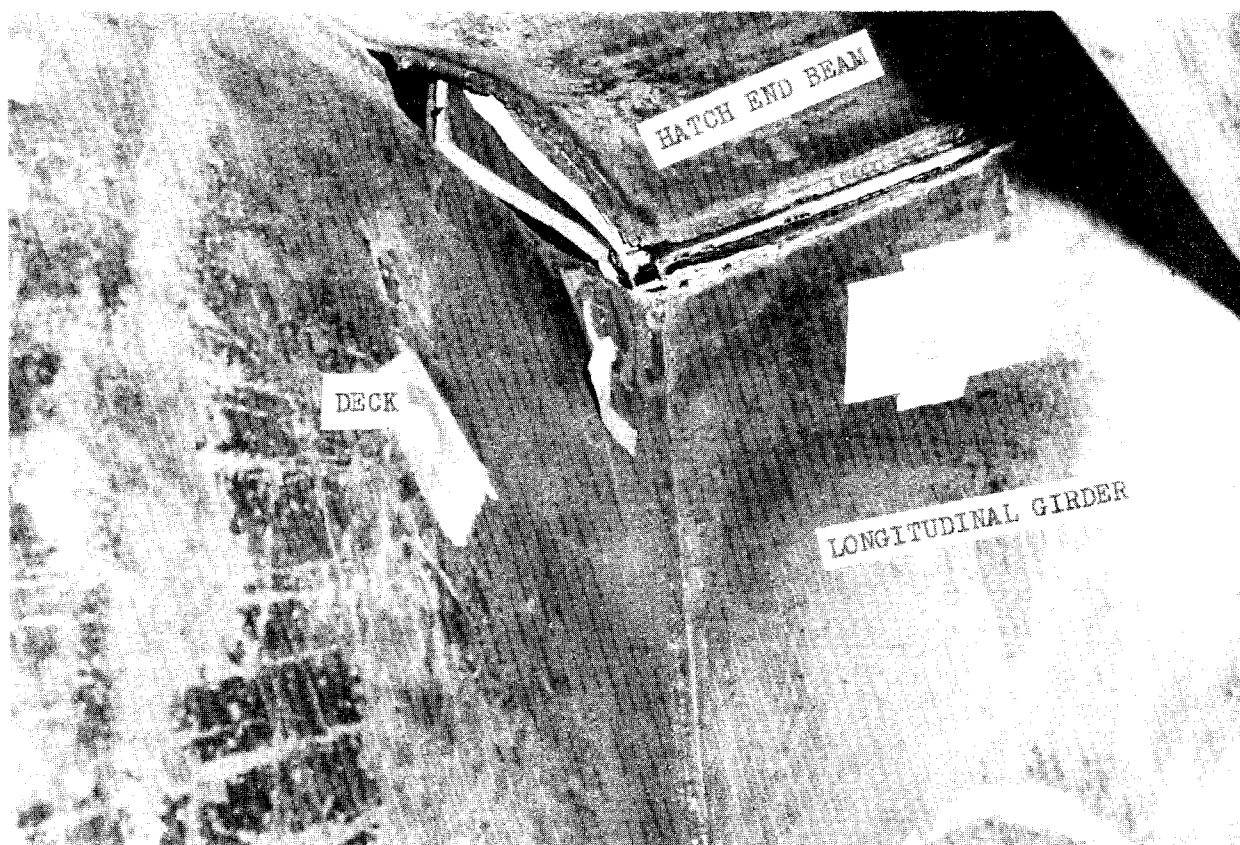
Fractures viewed from below deck, outboard and forward of hatch end beam.
