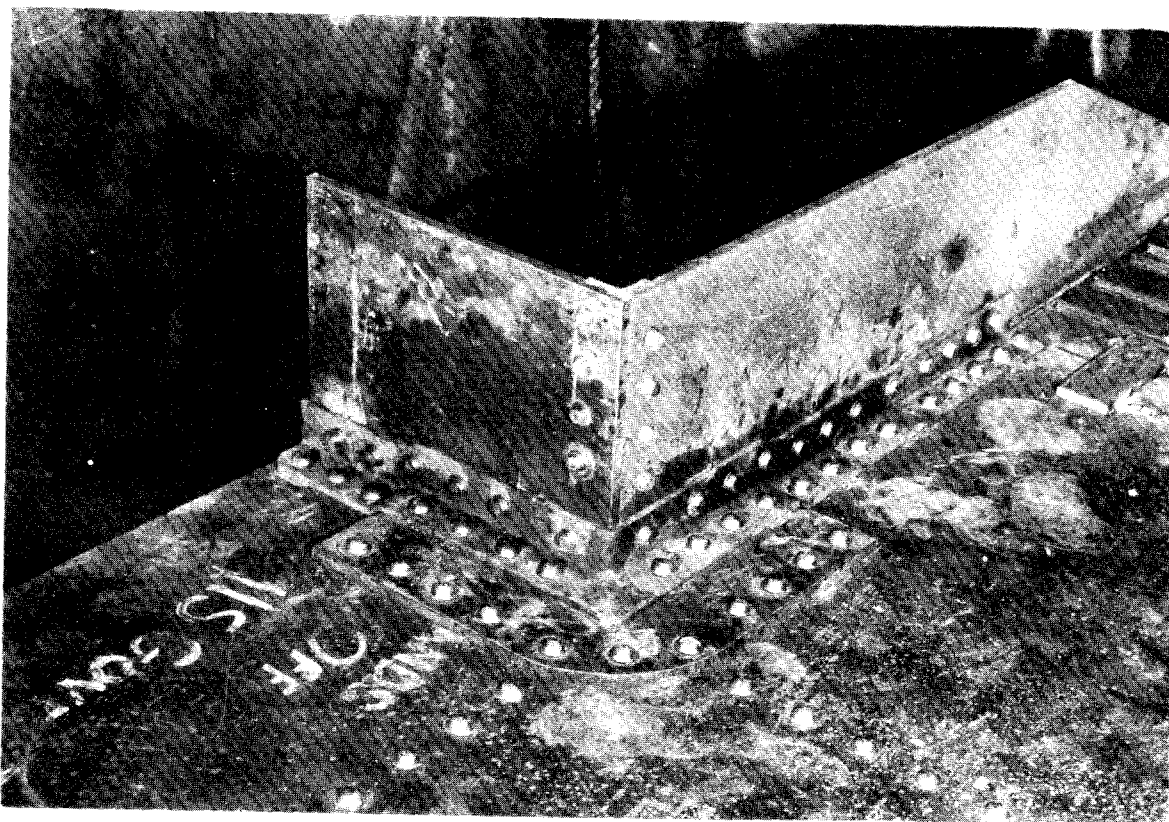
Before failure: View of corner from above deck

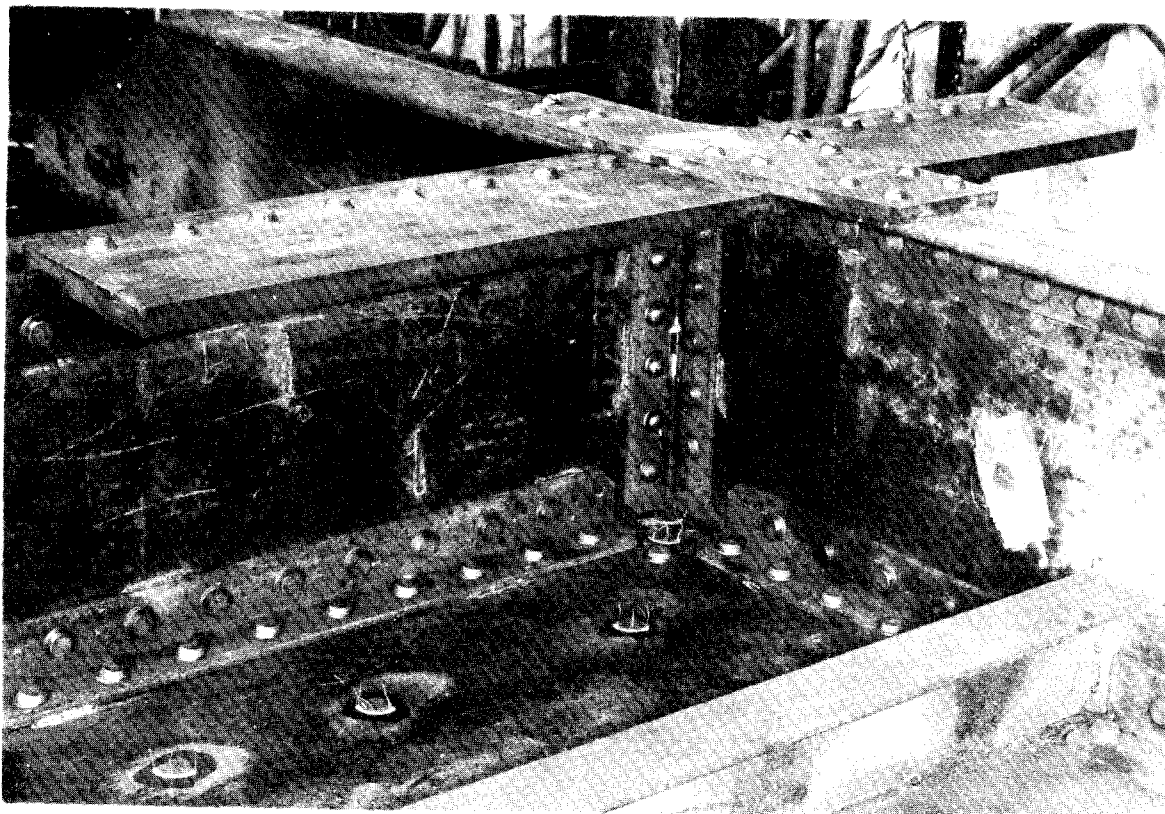
FIG. 12 - SPECIMEN 16

Before failure: Below deck, looking aft and inboard
