No.76 IACS Guidelines for Surveys, Assessment and Repair of Hull Structure - Bulk Carriers

(1994,
Rev.1
June 2001)

**Guidelines for Surveys, Assessment and Repair of Hull
Structure**

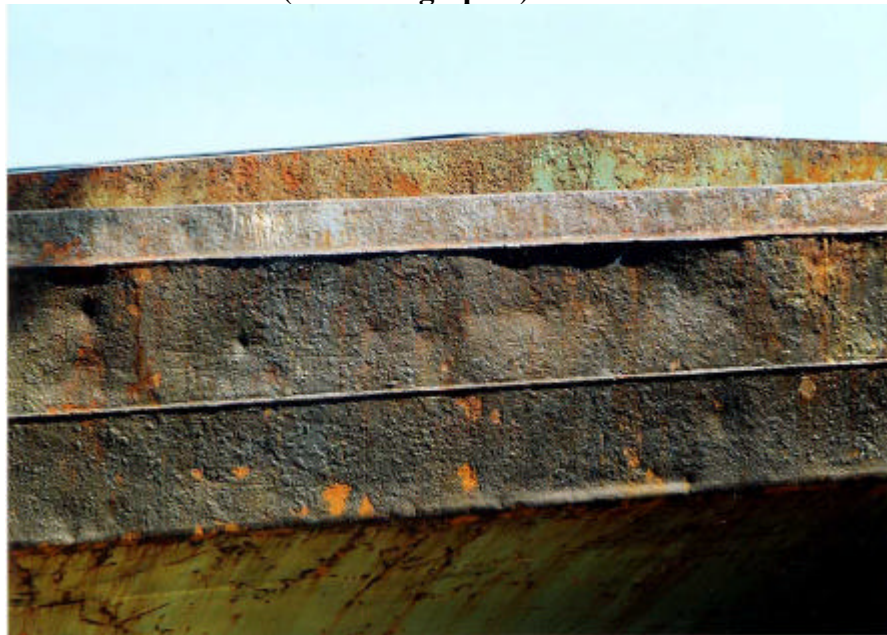
- 3.1.1 The level of wastage of under-deck stiffeners/structure in cross deck may have to be established by means of thickness measurements. The combined effect of the marine environment and the high humidity atmosphere within cargo hold s will give rise to a high corrosion rate.
- 3.1.2 Severe corrosion of the hatch coaming plating inside cargo hold and topside tank plating vertical strake may occur due to difficult access for the maintenance of the protective coating. This may lead to fractures in the structure (See **Photograph 1**).

Photograph 1 **Heavy corrosion of hatch coaming and topside tank plating vertical strake**

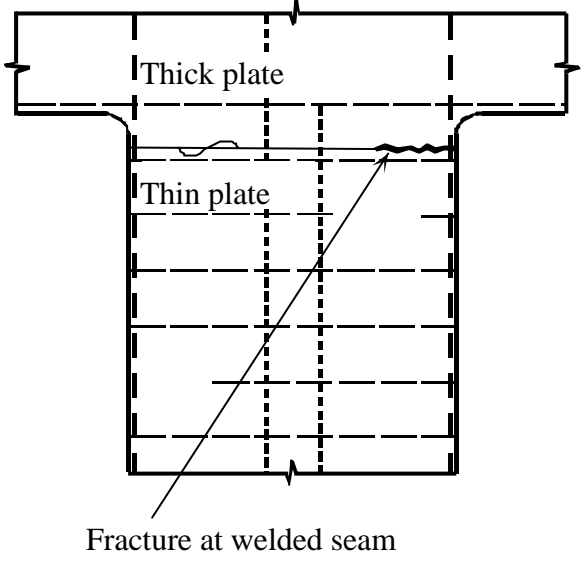
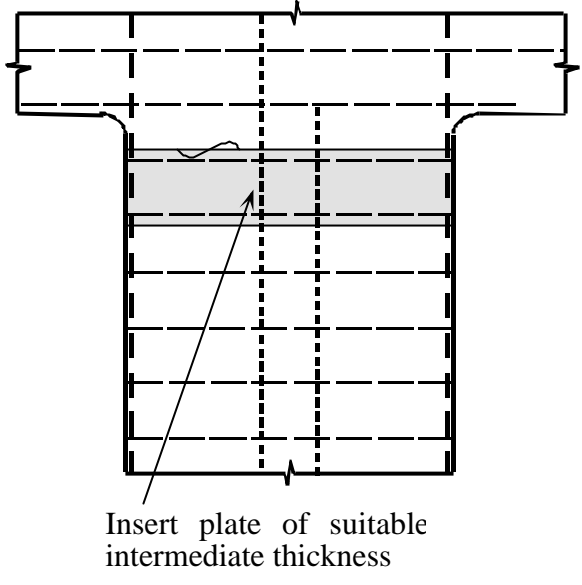
BULK CARRIERS		Guidelines for Surveys, Assessment and Repair of Hull Structure	
Part 1	Cargo hold region	Example No.	
Area 1	Deck structure	2-a	
Detail of damage		Fractures of welded seam between thick plate and thin plate at cross deck	
Sketch of damage		Sketch of repair

<p>Thick plate</p> <p>Thin plate</p> <p>Fracture at welded seam</p>

<p>Insert plate of suitable intermediate thickness</p>	
Notes on possible cause of damage		Notes on repairs	
<ol style="list-style-type: none"> 1. Stress concentration created by abrupt change in deck plating thickness. 2. In-plane bending in cross deck strip due to torsional (longitudinal) movements of ship sides. 3. Welded seam not clear of tangent point of hatch corner. 		<ol style="list-style-type: none"> 1. Insert plate of intermediate thickness is recommended. 2. Smooth transition between plates (beveling) should be considered.

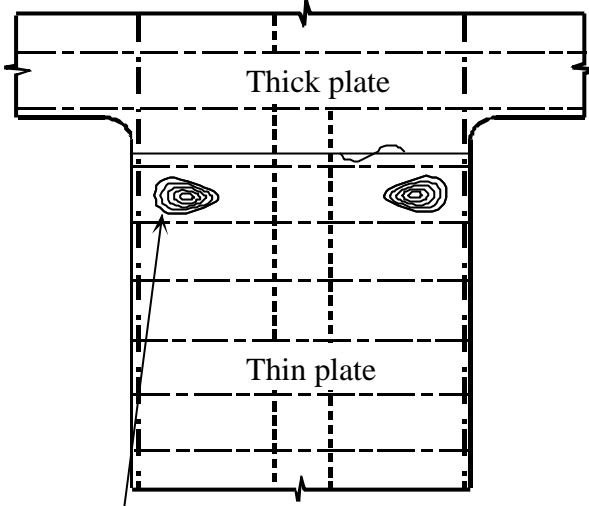
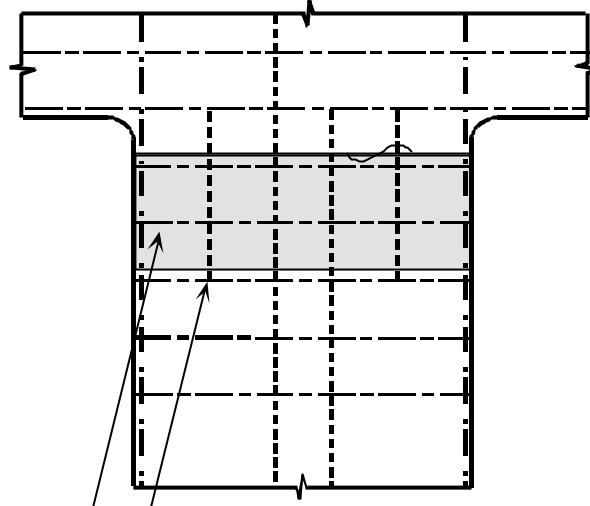
BULK CARRIERS		Guidelines for Surveys, Assessment and Repair of Hull Structure	
Part 1	Cargo hold region	Example No.	
Area 1	Deck structure	2-b	
Detail of damage		Plate buckling in thin plate near thick plate at cross deck	
Sketch of damage		Sketch of repair

<p>Buckling of cross deck plating (Buckling of hatch end structure should be examined. Refer to Example 7-a.)</p>

<p>Additional transverse stiffening and/or insertion of plate with suitable intermediate thickness</p>	
Notes on possible cause of damage		Notes on repairs	
<ol style="list-style-type: none"> 1. In-plane bending of cross deck strip due to torsional (longitudinal) movement of ship sides, often in combination with corrosion. 2. Insufficient plate thickness and/or transverse stiffening. 		<ol style="list-style-type: none"> 1. Transverse stiffeners extending from hatch sides towards centerline at least 10% of breadth of hatch, and/or increased plate thickness in the same area.

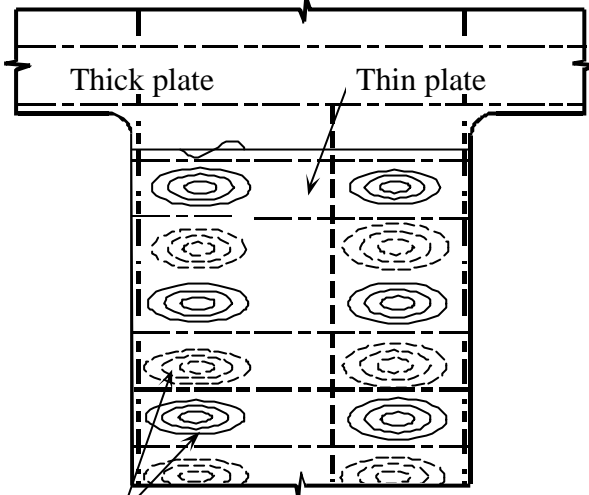
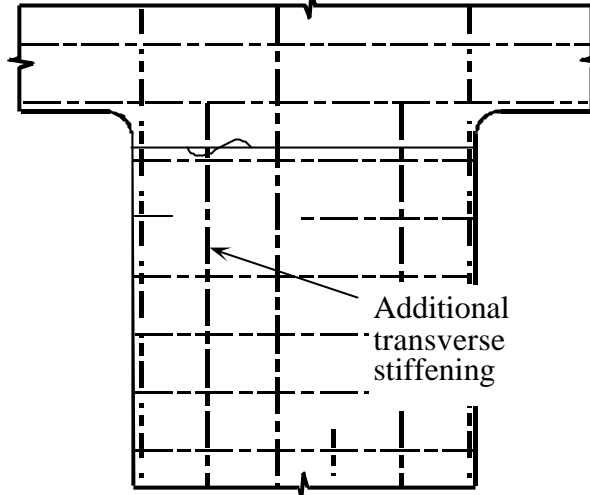
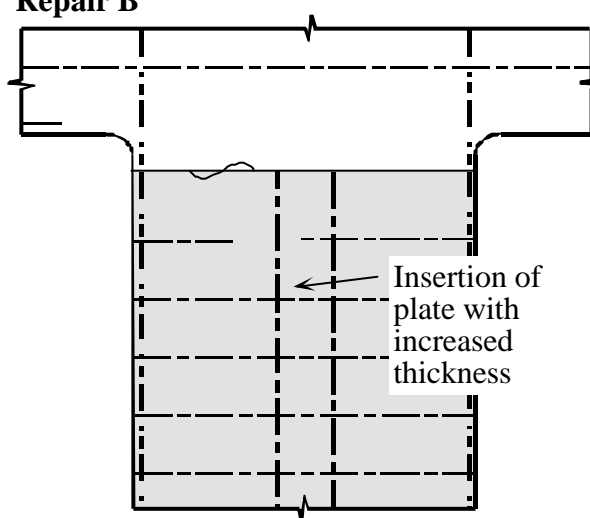
BULK CARRIERS		Guidelines for Surveys, Assessment and Repair of Hull Structure	
Part 1	Cargo hold region	Example No.	
Area 1	Deck structure	2-c	
Detail of damage		Overall buckling of cross deck plating	
Sketch of damage		Sketch of repair

<p>Buckling of cross deck plating (Buckling of hatch end structure should be examined. Refer to Example 7-a.)</p>		<p>Repair A</p>

Notes on possible cause of damage		Notes on repairs	
<ol style="list-style-type: none"> 1. Transverse compression of deck due to sea load. 2. Transverse compression of deck due to excessive loading in two adjacent holds. 3. Insufficient plate thickness and/or transverse stiffening. 		<ol style="list-style-type: none"> 1. Repair A Plating of original thickness in combination with additional transverse stiffening. 2. Repair B Insertion of plating of increased thickness.

<p>Repair B</p>

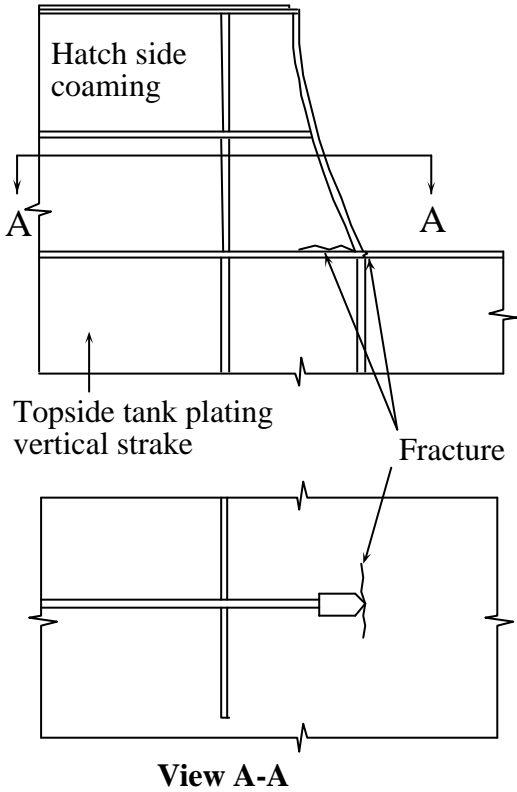
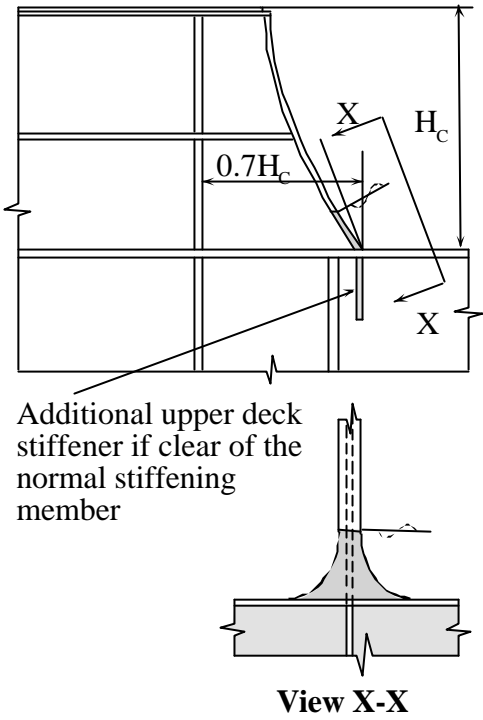
BULK CARRIERS		Guidelines for Surveys, Assessment and Repair of Hull Structure	
Part 1	Cargo hold region	Example No.	
Area 1	Deck structure	3-a	
Detail of damage		Fractures in the web or in the deck at the toes of the longitudinal hatch coaming termination bracket	
Sketch of damage		Sketch of repair

<p>Hatch side coaming</p> <p>Topside tank plating vertical strake</p> <p>Fracture</p> <p>View A-A</p>

<p>Additional upper deck stiffener if clear of the normal stiffening member</p> <p>View X-X</p>	
Notes on possible cause of damage		Notes on repairs	
<ol style="list-style-type: none"> 1. This damage is caused by stress concentrations attributed to the design of the bracket. 		<ol style="list-style-type: none"> 1. The design of the bracket can be altered as shown above, however, it is to be ensured that an additional under deck stiffener is provided at the toe of the termination bracket, where the toe is clear of the normal stiffening member. 2. Full penetration weld for a distance of $0.15 H_C$ from toe of side coaming termination bracket and for connection of athwartship gusset bracket to deck. 3. The fracture in deck plating to be veed-out and rewelded or deck plating cropped and part renewed as appropriate, using low hydrogen electrodes for welding.

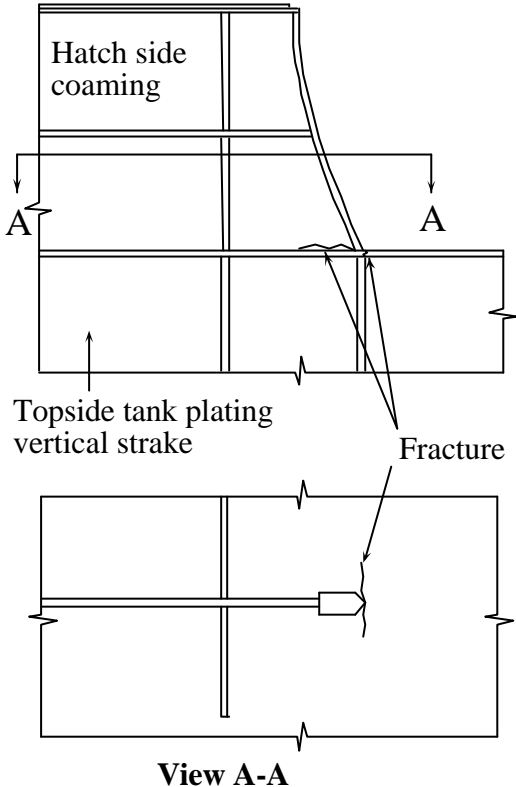
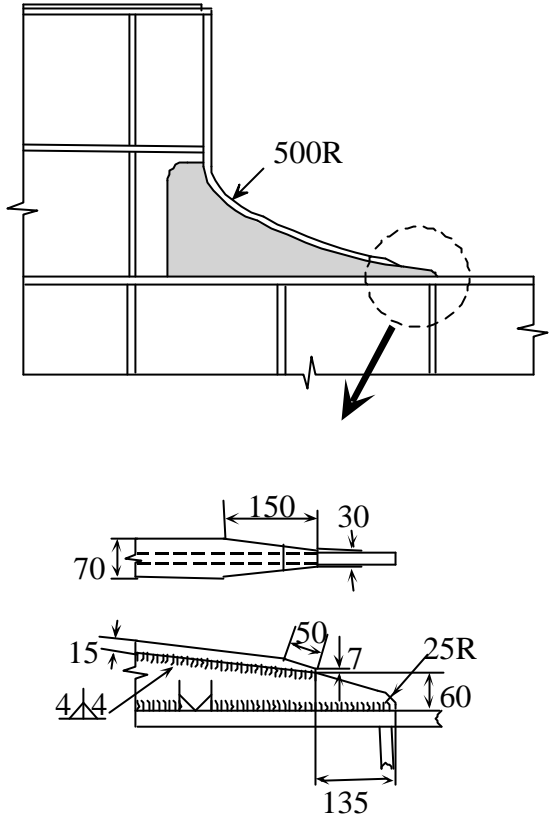
BULK CARRIERS		Guidelines for Surveys, Assessment and Repair of Hull Structure	
Part 1	Cargo hold region	Example No.	
Area 1	Deck structure	3-b	
Detail of damage		Fractures in the web or in the deck at the toes of the longitudinal hatch coaming termination bracket	
Sketch of damage		Sketch of repair

<p>Hatch side coaming</p> <p>Topside tank plating vertical strake</p> <p>Fracture</p> <p>View A-A</p>

<p>500R</p> <p>150 30</p> <p>70</p> <p>15 4 4 50 7 25R 60</p> <p>135</p>	
Notes on possible cause of damage		Notes on repairs	
<ol style="list-style-type: none"> 1. This damage is caused by stress concentrations attributed to the design of the bracket. 		<ol style="list-style-type: none"> 1. The design of the bracket can be altered as shown above, however, it is to be ensured that an additional under deck stiffener is provided at the toe of the termination bracket, where the toe is clear of the normal stiffening member. 2. The fracture in deck plating to be veed-out and rewelded or deck plating cropped and part renewed as appropriate, using low hydrogen electrodes for welding.

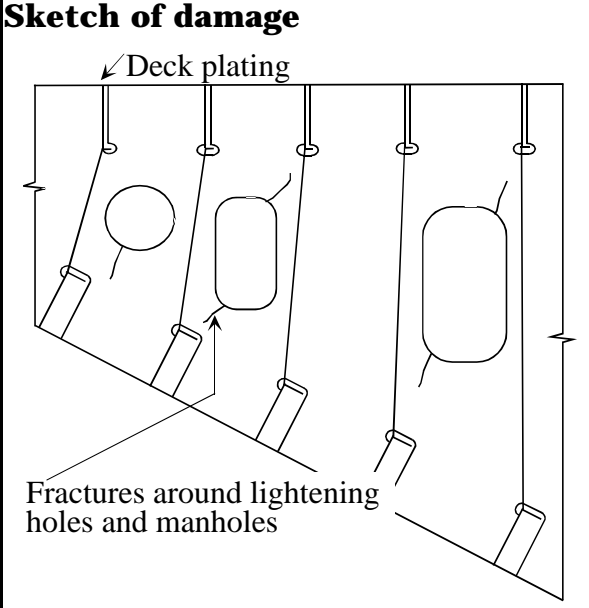
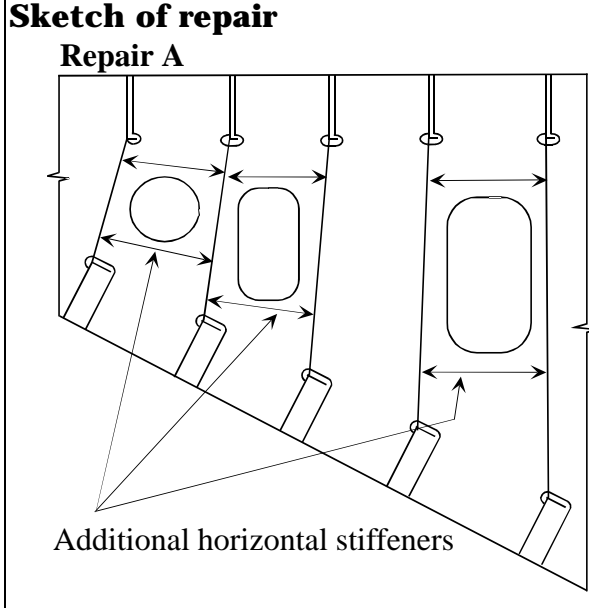
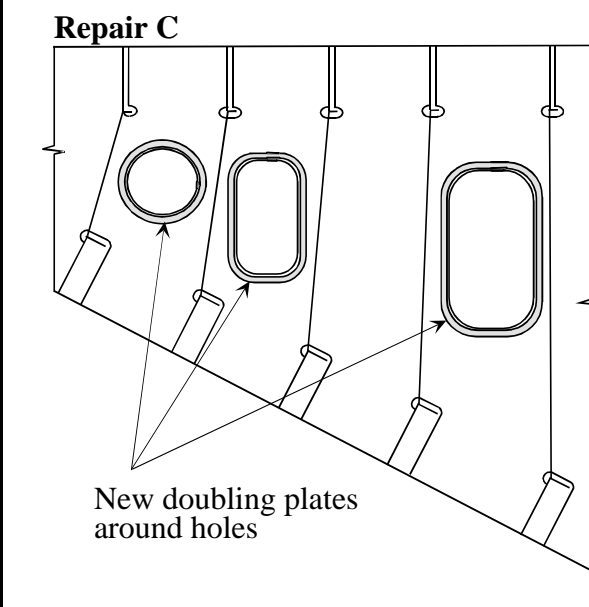
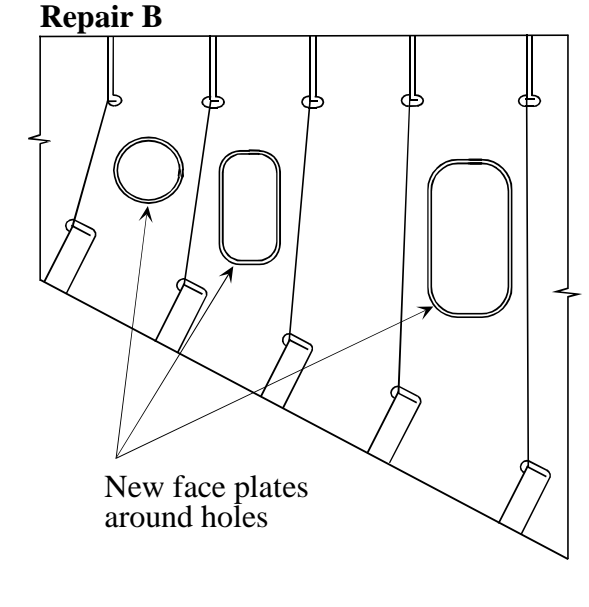
BULK CARRIERS		Guidelines for Surveys, Assessment and Repair of Hull Structure	
Part 1	Cargo hold region	Example No. 1	
Area 2	Topside tank structure		
Detail of damage		Fractures around unstiffened lightening holes and manholes in wash bulkhead	
Sketch of damage		Sketch of repair

<p>Deck plating</p> <p>Fractures around lightening holes and manholes</p>

<p>Repair B</p> <p>New face plates around holes</p>	
Notes on possible cause of damage		Notes on repairs	
<ol style="list-style-type: none"> General levels of corrosion and presence of stress concentration. 		<ol style="list-style-type: none"> Corroded/fractured plate should be cropped and renewed with plating of enhanced thickness. Reinforcement should be considered.

<p>Repair A</p> <p>Additional horizontal stiffeners</p>

<p>Repair C</p> <p>New doubling plates around holes</p>

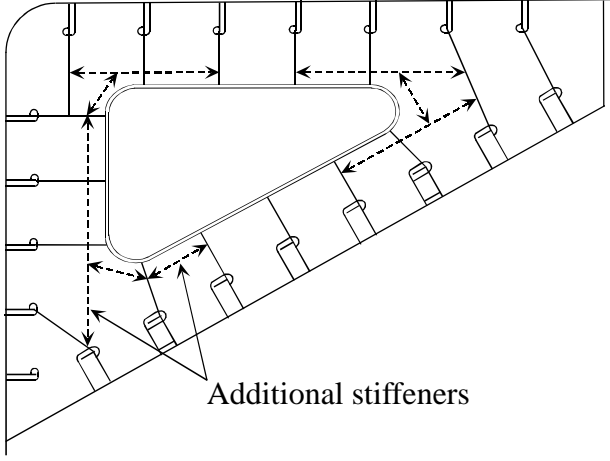
<p>Areas of excessive corrosion, and subsequent buckling and/or</p>

<p>Additional stiffeners</p>	
Notes on possible cause of damage		Notes on repairs	
<ol style="list-style-type: none"> 1. Insufficient buckling strength. 2. Corrosion due to stress concentration at corners. 		<ol style="list-style-type: none"> 1. Buckled plating is to be cropped and parts renewed, if necessary. 2. Additional stiffeners as shown above and/or renewal with plating of increased thickness should be considered.

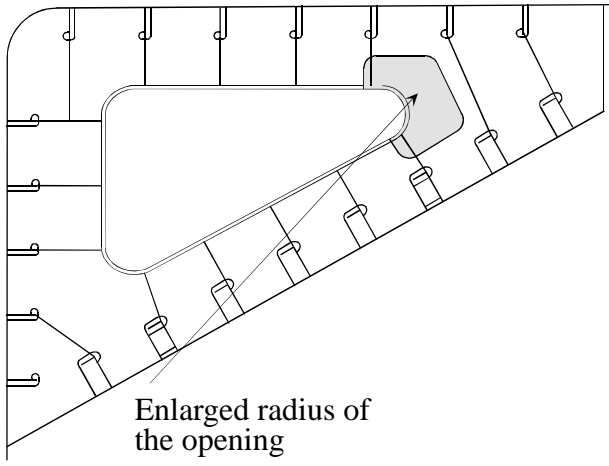
<p>Areas of excessive corrosion, and subsequent buckling and/or fracture</p>

<p>Enlarged radius of the opening</p>	
Notes on possible cause of damage		Notes on repairs	
<ol style="list-style-type: none"> 1. Corrosion caused by stress concentration at the corner due to insufficient radius for the opening. 		<ol style="list-style-type: none"> 1. Corroded/buckled plating is to be cropped and parts renewed with plating of increased thickness and additional stiffeners are preferable to minimize deflection. 2. An attempt should be made to improve the design of the radius if felt necessary.

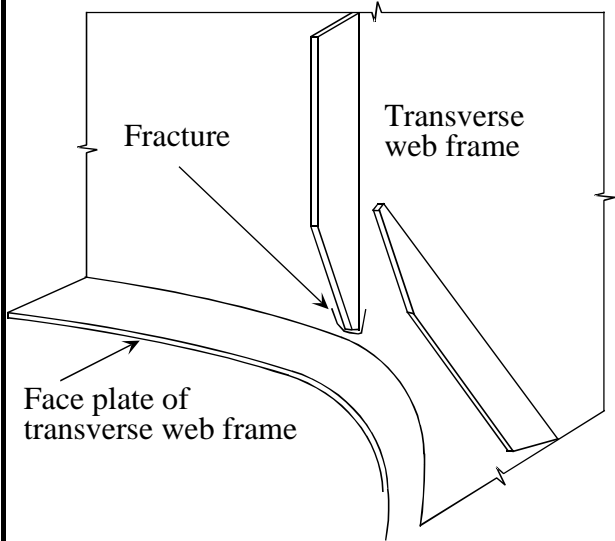
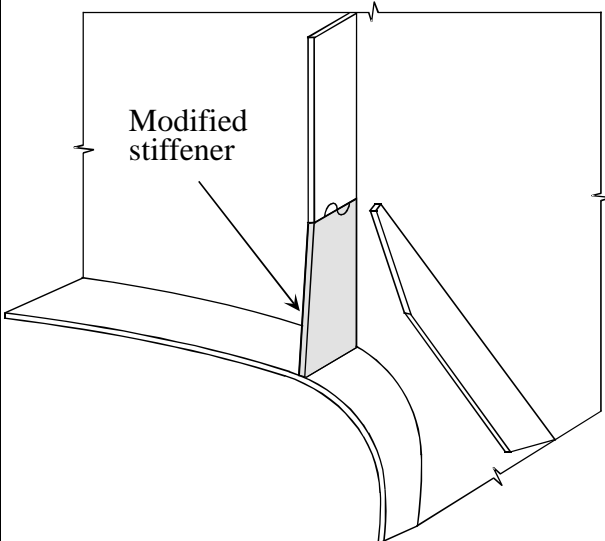
Notes on possible cause of damage		Notes on repairs	
<p>1. Stress concentration.</p>		<p>1. Fracture can be veed-out and welded provided the plating is not generally corroded. If necessary, fractured plating should be cropped and renewed.</p> <p>2. Excessive stress concentration at the end of stiffener should be avoided.</p>

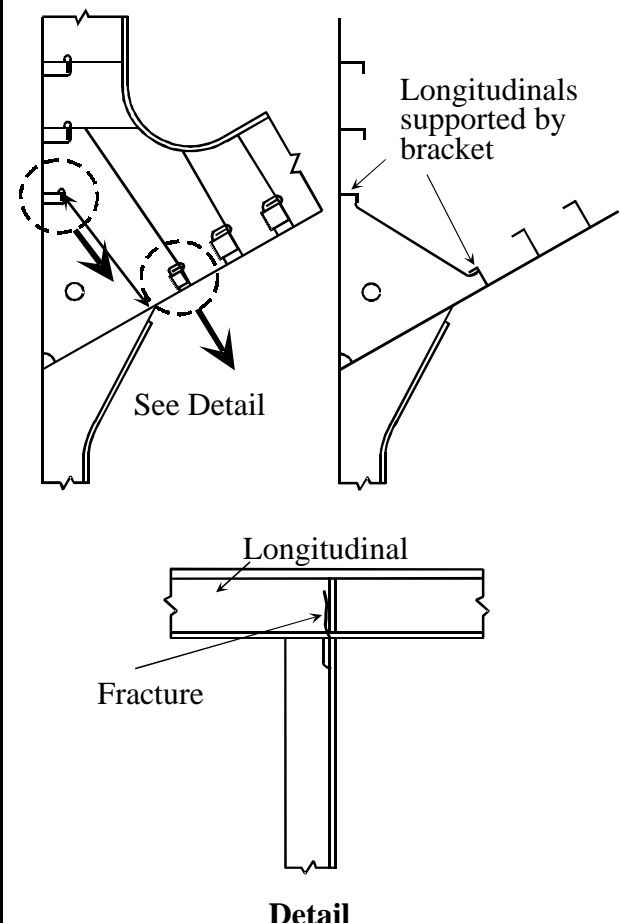
<p>The sketch shows a longitudinal beam supported by a bracket. A fracture is indicated at the connection. A detail view shows the fracture in the longitudinal beam. Labels include 'Longitudinals supported by bracket', 'See Detail', 'Longitudinal', and 'Fracture'.</p>	
Notes on possible cause of damage		Notes on repairs	
<p>1. Insufficient scantling for torsional rigidity (The lowest longitudinal is usually supported by bracket(s) as shown in the above and smaller scantling may be adopted. However, the lowest longitudinal undergoes torsion from side shell frame through bracket(s) and may suffer fracture.)</p>		<p>1. Fractured part to be cropped and renewed. 2. Size of bracket should be increased</p>

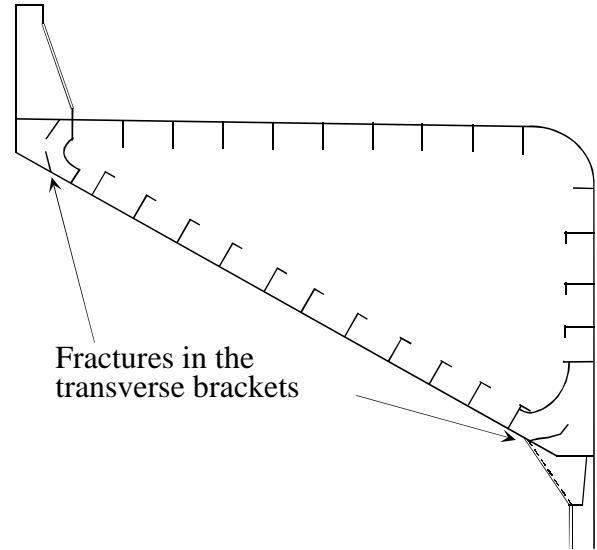
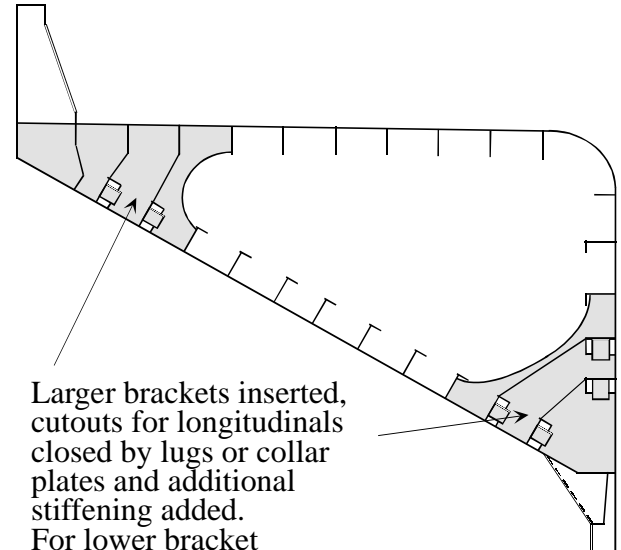
<p>Fractures in the transverse brackets</p>

<p>Larger brackets inserted, cutouts for longitudinals closed by lugs or collar plates and additional stiffening added. For lower bracket alternatively increase the thickness</p>	
Notes on possible cause of damage		Notes on repairs	
<ol style="list-style-type: none"> 1. General levels of corrosion and presence of stress concentrations. 2. Misalignment of the brackets with adjoining structure, e.g. side shell frame brackets and/or coaming brackets. 3. High shear stresses due to insufficient bracket size. 4. Inadvertent overloading. 		<ol style="list-style-type: none"> 1. If the damage is caused by misalignment with the side shell frame brackets or the hatch coaming brackets the misalignment is to be rectified and the replacement by larger brackets incorporated only if considered necessary.

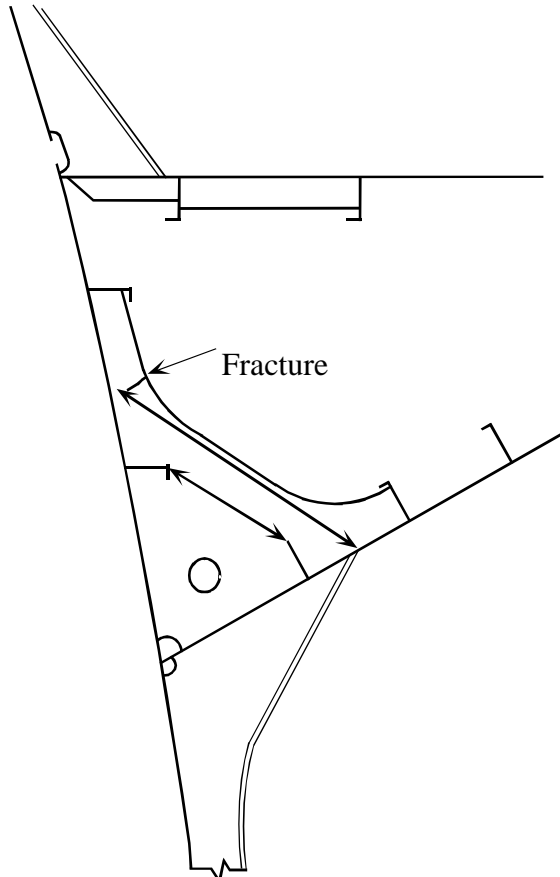
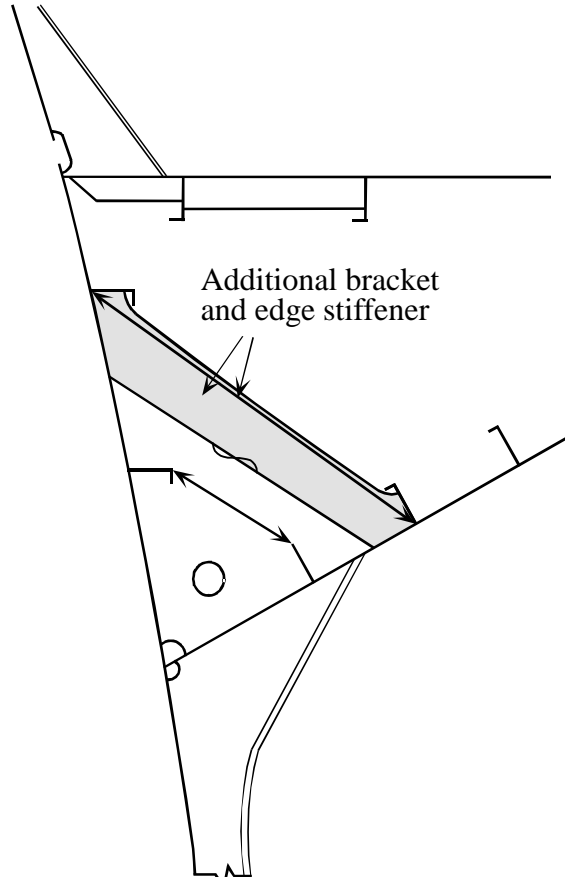
Notes on possible cause of damage		Notes on repairs	
<ol style="list-style-type: none"> 1. Insufficient strength. 2. Corrosion. 		<ol style="list-style-type: none"> 1. Fractured part to be cropped and renewed. 2. If the fractured part is free from corrosion, increased size and thickness should be considered. Partial renewal of the bracket may be accepted depending on the nature of the fracture.

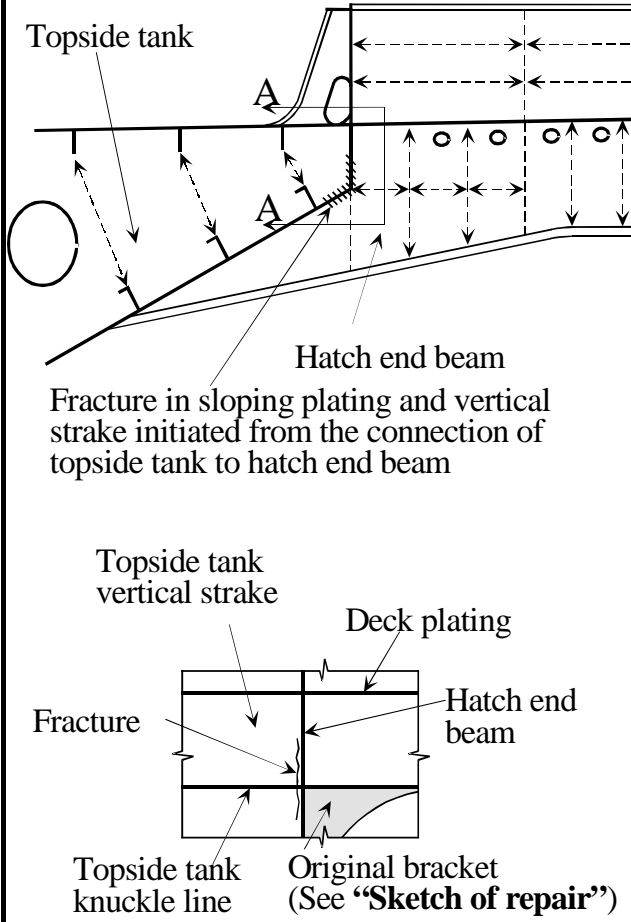
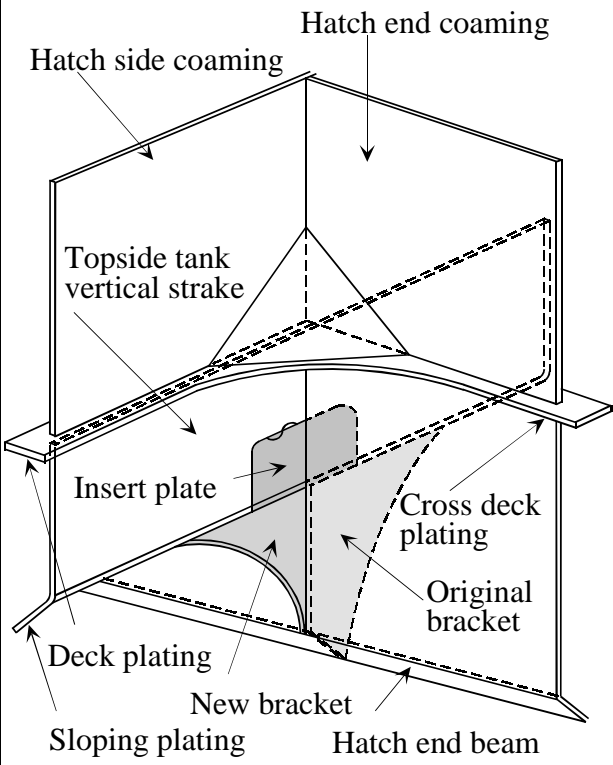
<p>Topside tank</p> <p>Hatch end beam</p> <p>Fracture in sloping plating and vertical strake initiated from the connection of topside tank to hatch end beam</p> <p>Topside tank vertical strake</p> <p>Deck plating</p> <p>Fracture</p> <p>Hatch end beam</p> <p>Topside tank knuckle line</p> <p>Original bracket (See "Sketch of repair")</p> <p>View A-A</p>

<p>Hatch side coaming</p> <p>Hatch end coaming</p> <p>Topside tank vertical strake</p> <p>Insert plate</p> <p>Cross deck plating</p> <p>Original bracket</p> <p>Deck plating</p> <p>Sloping plating</p> <p>New bracket</p> <p>Hatch end beam</p>

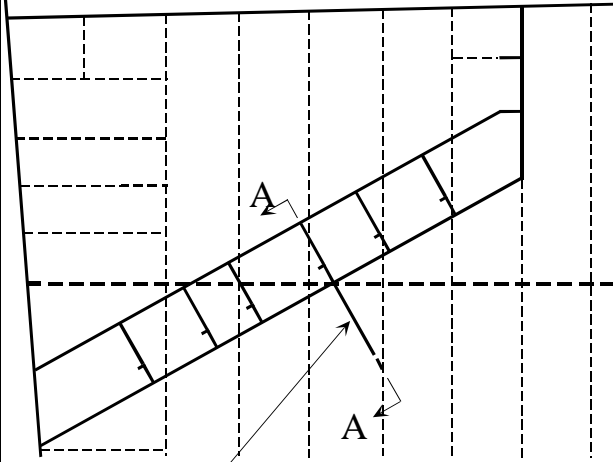
<p>New additional brackets</p> <p>Topside Boatswain store</p> <p>No.1 C.H. F.P.T</p> <p>Section A-A</p>	
Notes on possible cause of damage		Notes on repairs	
<ol style="list-style-type: none"> 1. Damage caused by hard spot at intersection of the topside tank sloping plating and boatswain's store deck plating (fore peak tank top plating). 		<ol style="list-style-type: none"> 1. Fractured plates to be cropped and renewed. 2. Stress concentration should be considered (Brackets were fitted on both sides for reinforcement).

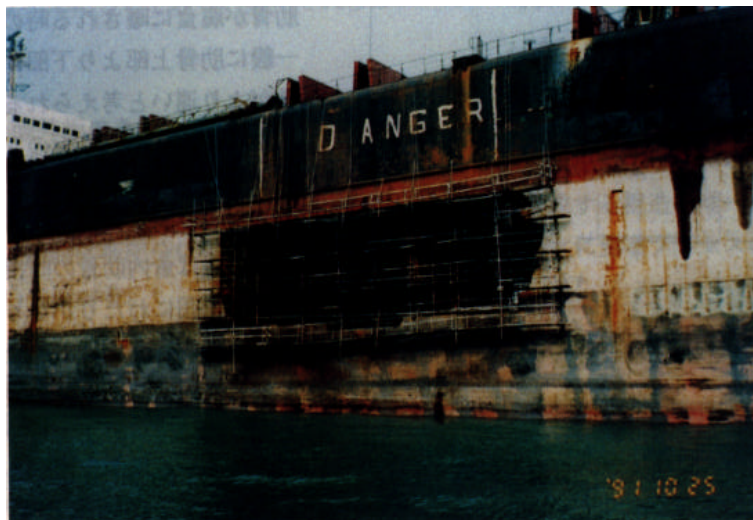
Photograph 2 Missing side shell structure (See Examples 4 and 5)

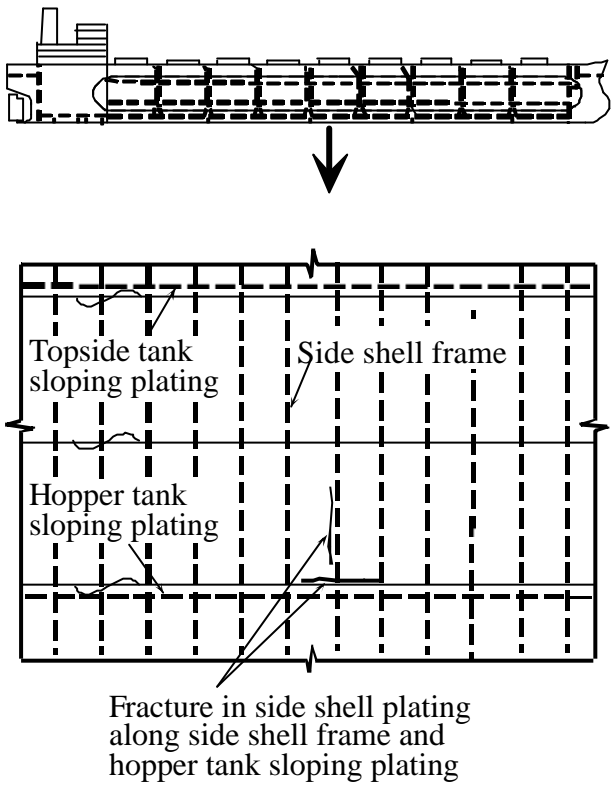
<p>Topside tank sloping plating</p> <p>Side shell frame</p> <p>Hopper tank sloping plating</p> <p>Fracture in side shell plating along side shell frame and hopper tank sloping plating</p>

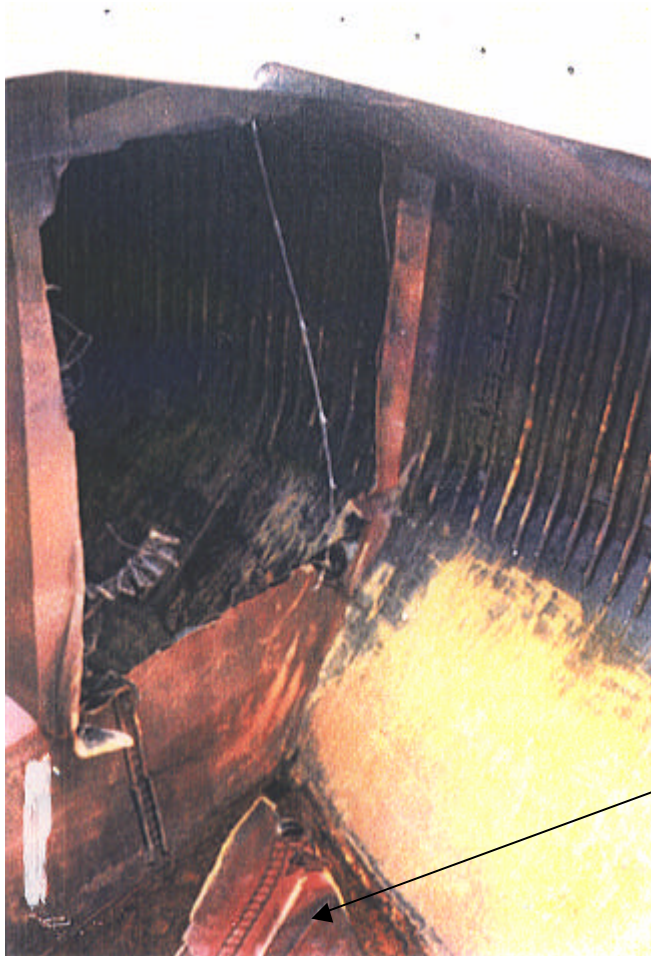
Photograph 1
Collapsed and detached
transverse bulkhead

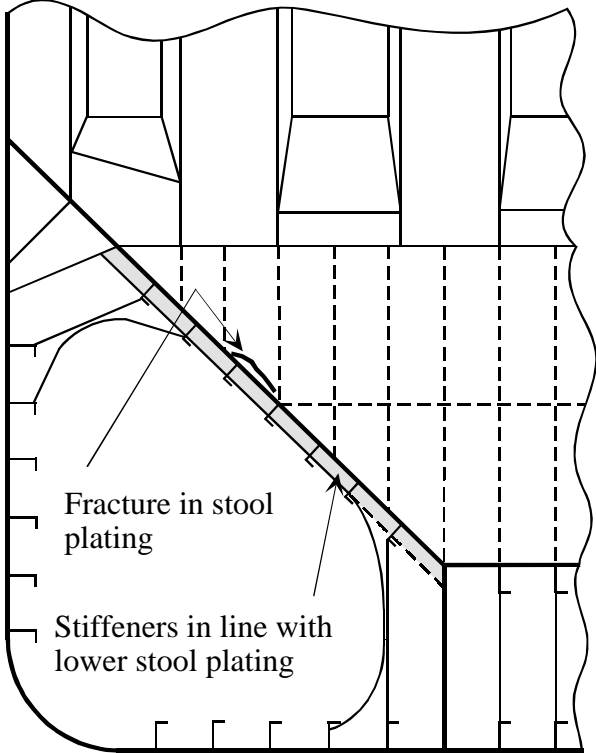
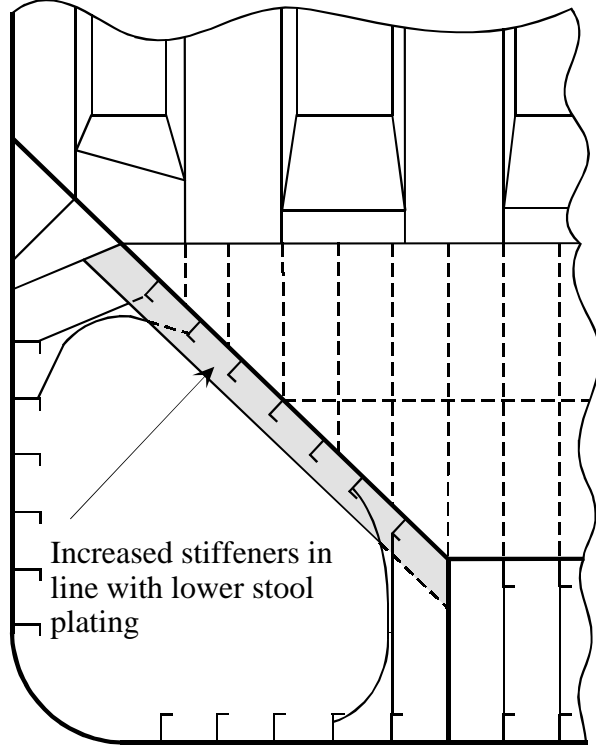
<p>Fracture in stool plating</p> <p>Stiffeners in line with lower stool plating</p>

<p>Increased stiffeners in line with lower stool plating</p>	
Notes on possible cause of damage		Notes on repairs	
<ol style="list-style-type: none"> 1. Insufficient strength of the connection 2. Corrosion 		<ol style="list-style-type: none"> 1. Fractured stool plating should be partly cropped and renewed (thicker plate) if considered necessary. 2. If the damage occurred due to insufficient strength, stiffeners in line with stool plating should be increased.

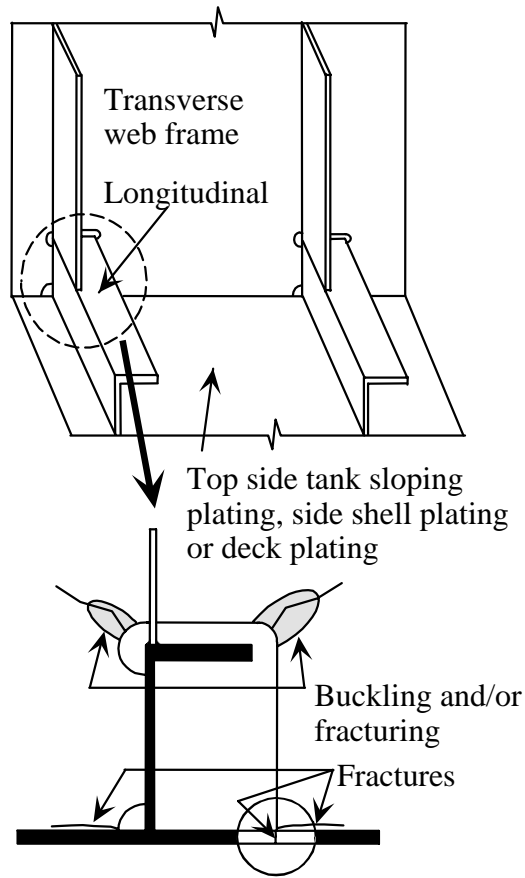
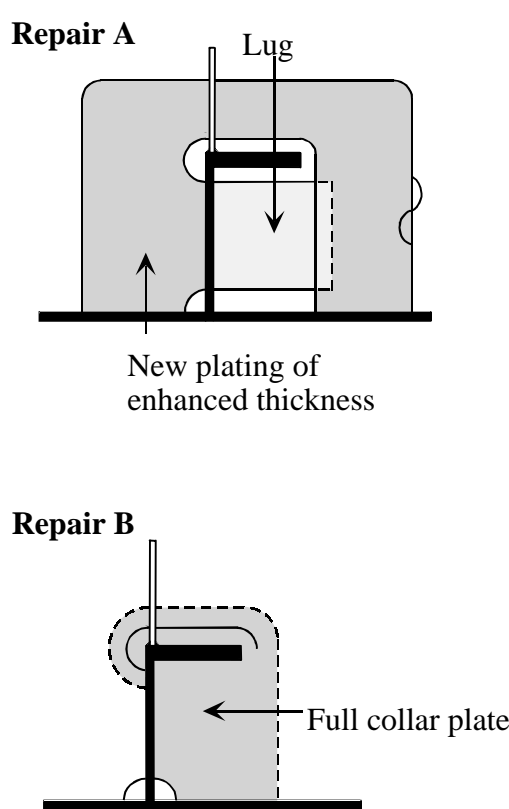
Notes on possible cause of damage		Notes on repairs	
<p>1. Damage can be caused by general levels of corrosion and presence of stress concentration associated with the presence of a cut-out.</p>		<p>1. If fractures are significant then crop and part renew the floor plating/transverse web otherwise the fracture can be veed-out and welded provided the plating is not generally corroded.</p> <p>2. Repair B is to be incorporated if the lug proves to be ineffective.</p>

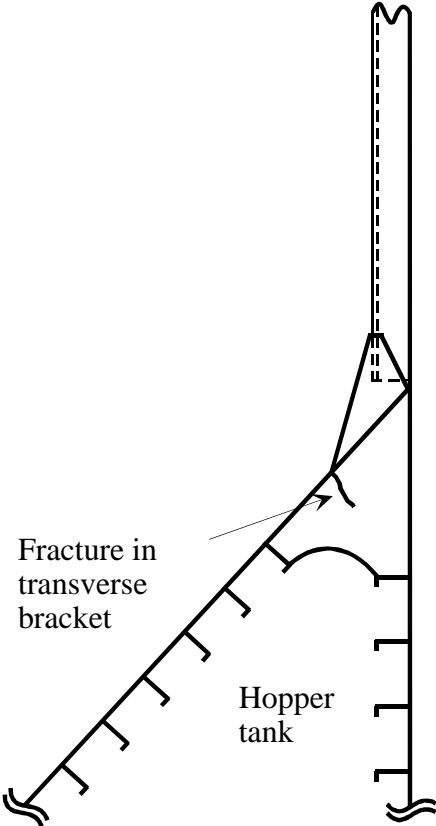
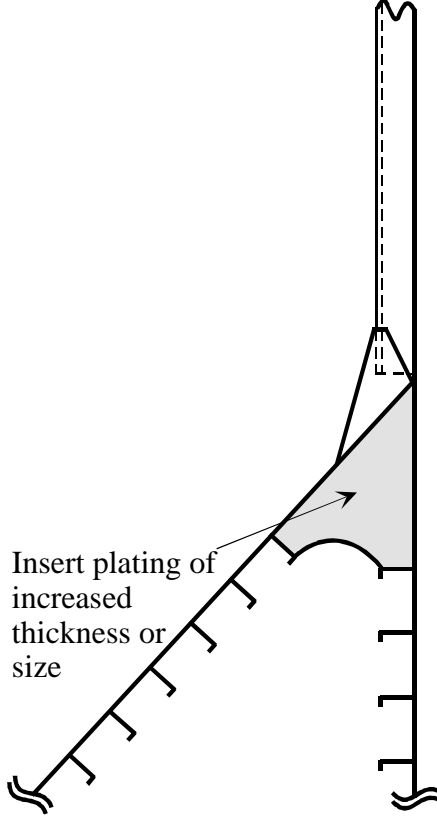
Notes on possible cause of damage		Notes on repairs	
<ol style="list-style-type: none"> 1. General levels of corrosion and presence of stress concentration. 2. Misalignment of the brackets with adjoining structure e.g. frame brackets. 3. High shear stresses due to insufficient bracket. 4. Inadvertent overloading. 		<ol style="list-style-type: none"> 1. If the damage is caused by misalignment with the frame bracket above, the misalignment is to be rectified. 2. Replacement by a bracket of increased thickness or size should be considered.

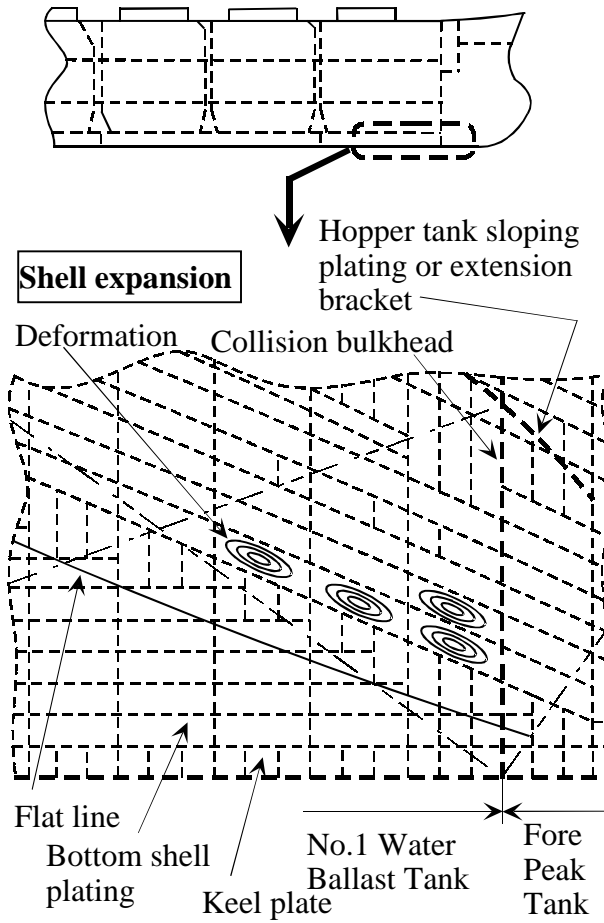
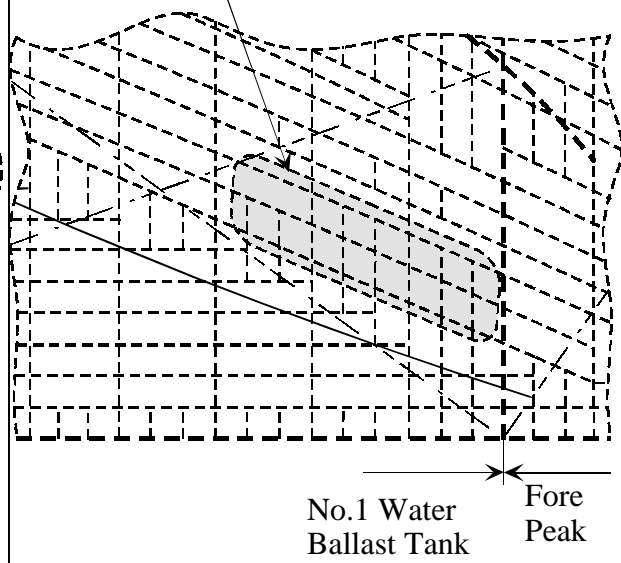
<p>Shell expansion</p> <p>Hopper tank sloping plating or extension bracket</p> <p>Deformation Collision bulkhead</p> <p>Flat line Bottom shell plating Keel plate No.1 Water Ballast Tank Fore Peak Tank</p>

<p>Reinforcement of bottom shell plating by new stiffeners</p> <p>No.1 Water Ballast Tank Fore Peak</p>	
Notes on possible cause of damage		Notes on repairs	
<ol style="list-style-type: none"> 1. Heavy weather. 2. Poor design for slamming. 3. Poor operation, i.e. negligence of heavy ballast. 		<ol style="list-style-type: none"> 1. Deformed bottom shell plating should be faired in place, or partly cropped and renewed if considered necessary. 2. Bottom shell plating should be reinforced by stiffeners.

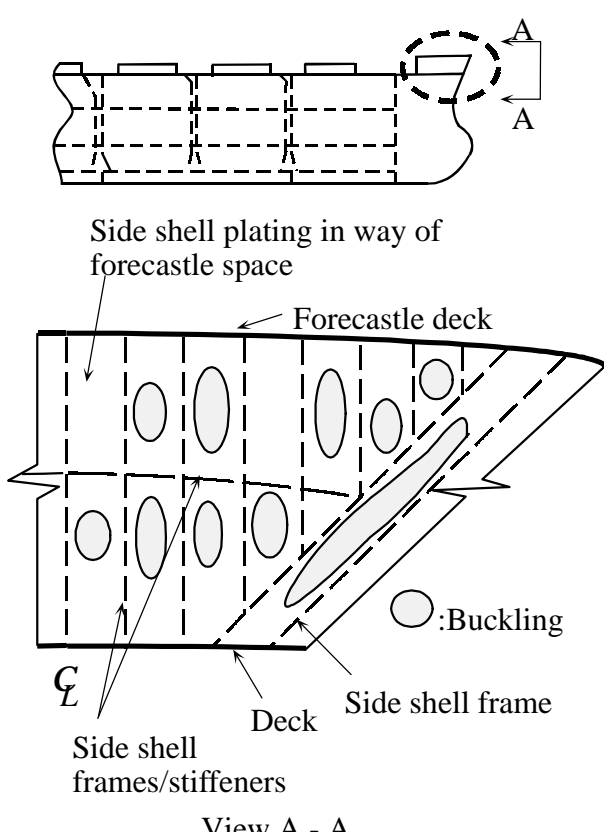
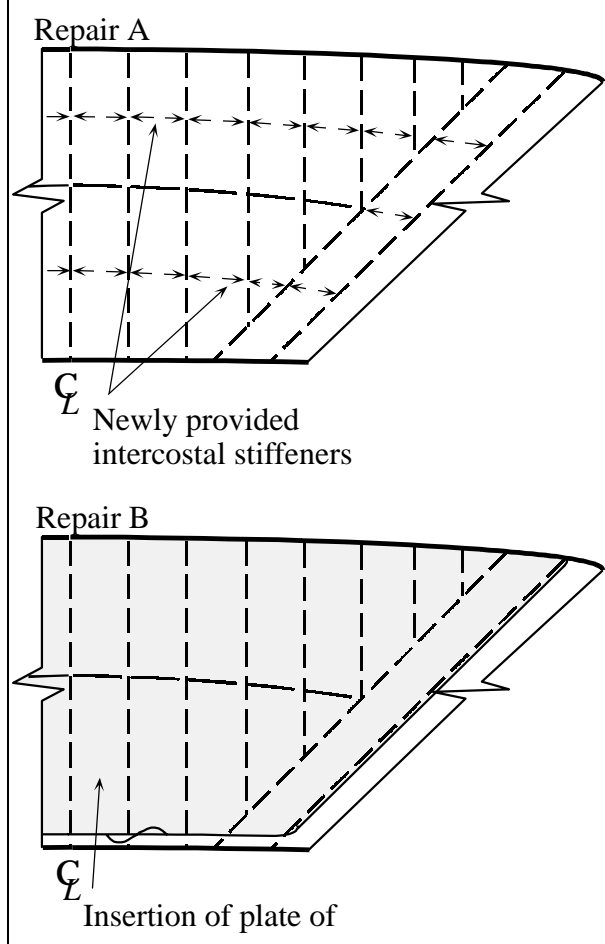
<p>Side shell plating in way of forecastle space</p> <p>Forecastle deck</p> <p>Deck</p> <p>Side shell frame</p> <p>Side shell frames/stiffeners</p> <p>View A - A</p> <p>○: Buckling</p>

<p>Repair A</p> <p>Newly provided intercostal stiffeners</p> <p>Repair B</p> <p>Insertion of plate of</p>	
Notes on possible cause of damage		Notes on repairs	
<ol style="list-style-type: none"> 1. Heavy weather. 2. Insufficient strength. 		<ol style="list-style-type: none"> 1. Deformed part should be cropped and part renewed. 2. Repair A Additional stiffeners between existing stiffeners should be considered. Repair B Insertion of plate of increased thickness with additional stiffeners.

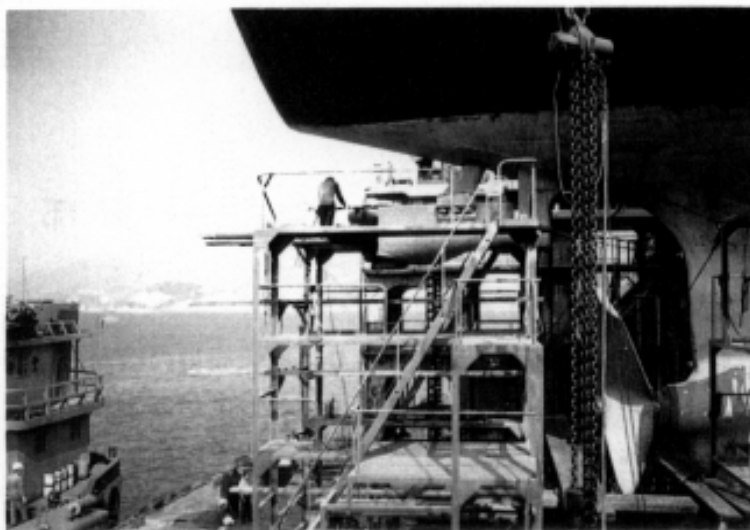
Photograph 1
Fractured rudder

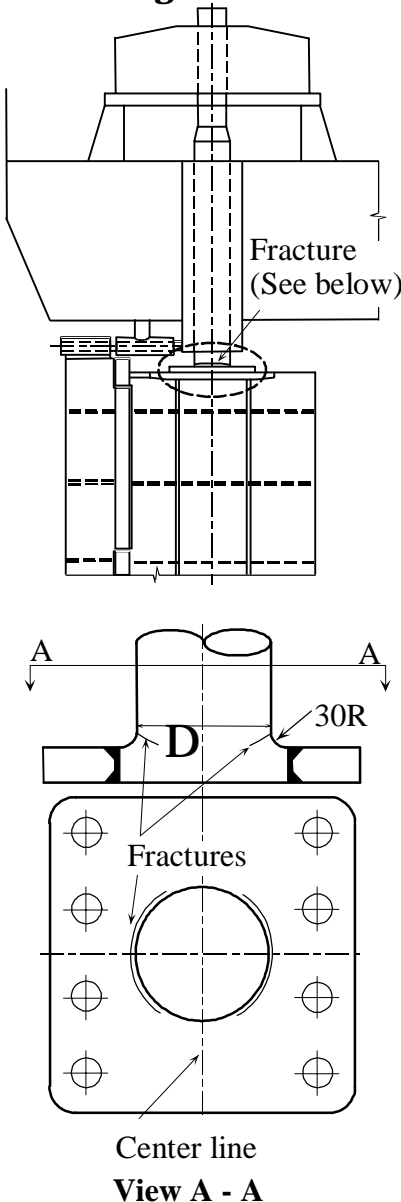
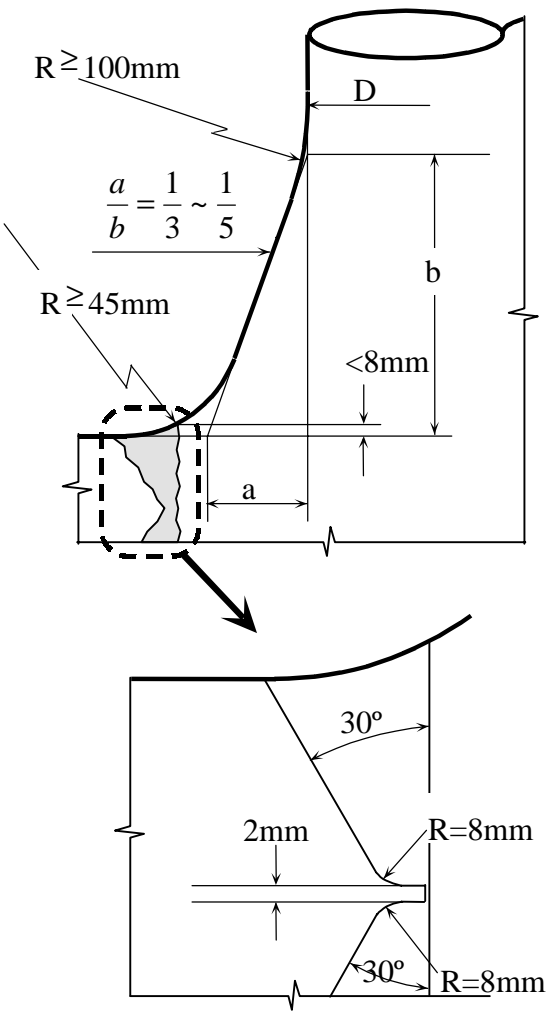
<p>Notes on possible cause of damage</p> <ol style="list-style-type: none"> Inadequate design for stress concentration in rudder stock. 	<p>Notes on repairs</p> <ol style="list-style-type: none"> Modification of detail design of rudder stock to reduce the stress concentration.
