No.76 IACS Guidelines for Surveys, Assessment and Repair of Hull Structure - Bulk Carriers

(1994,
Rev.1
June 2001)

**Guidelines for Surveys, Assessment and Repair of Hull
Structure**

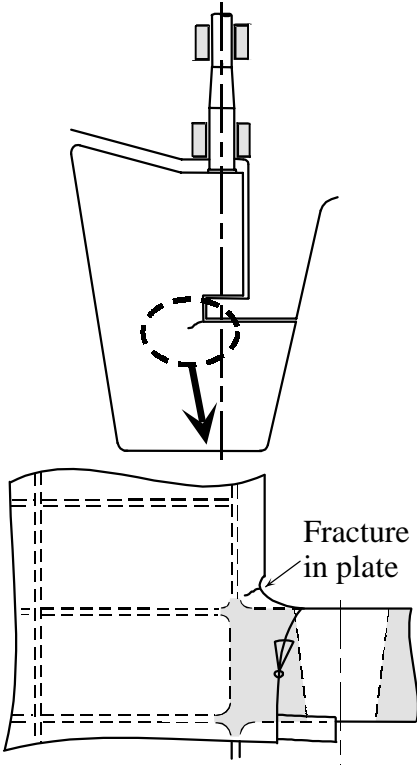
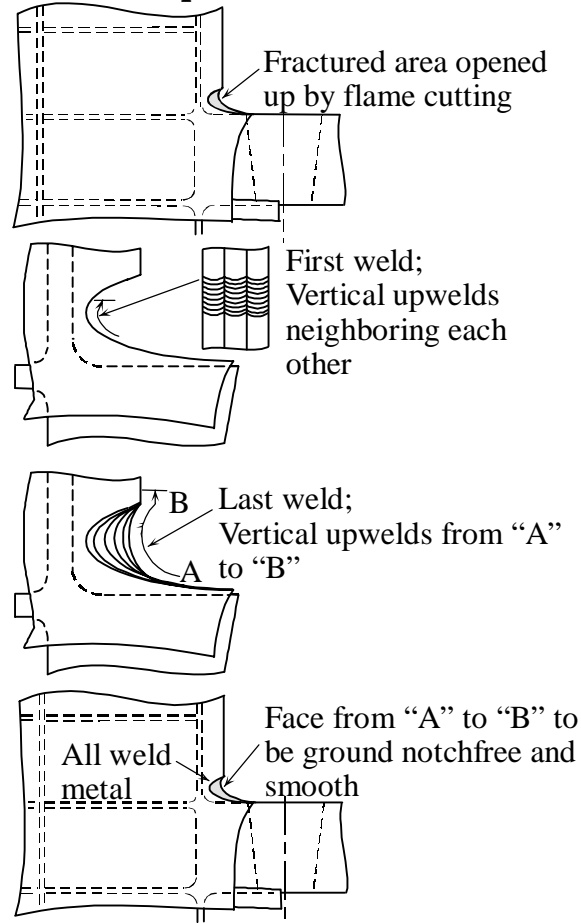
Notes on possible cause of damage		Notes on repairs	
<ol style="list-style-type: none"> 1. Stress concentration due to inadequate local design and/or fabrication notches in way of the butt weld between cast piece and plating. 		<ol style="list-style-type: none"> 1. Grooving-out and welding of the fracture is not always adequate (metallurgical notch in way of a high stressed area). 2. In the proposed repair procedure the metallurgical notches are shifted into a zone exposed to lower stresses. 3. After welding a modification of the radius according to the proposal in Example 5 is to be carried out. 4. In case of very small crack it can be ground off by increasing the radius.

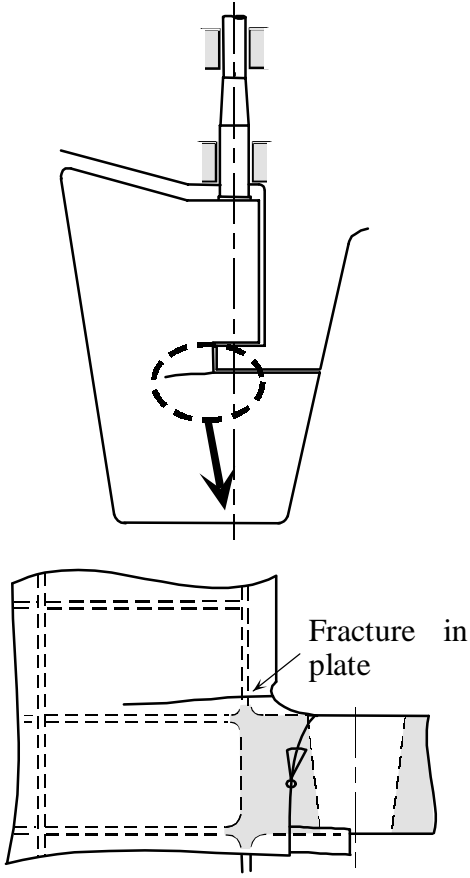
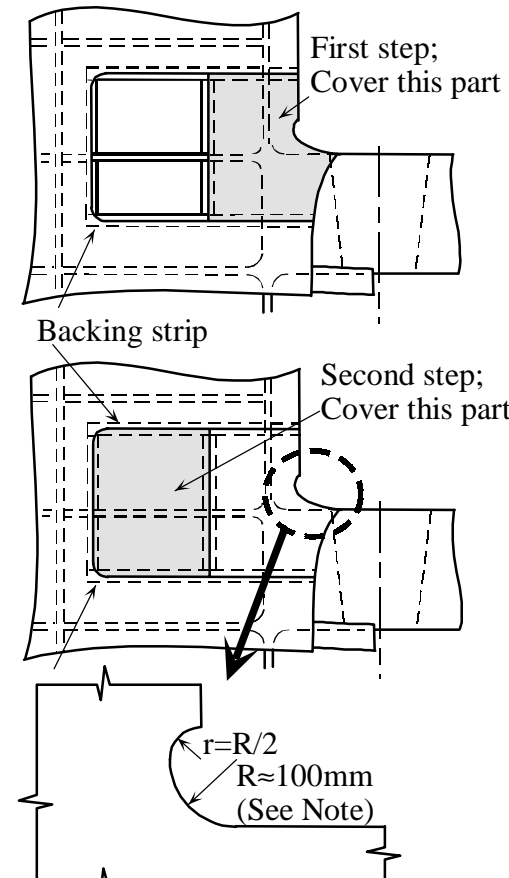
Notes on possible cause of damage		Notes on repairs	
<ol style="list-style-type: none"> 1. Stress concentration due to inadequate local design and/or fabrication notches in way of the butt weld between cast piece and plating. 		<ol style="list-style-type: none"> 1. Fractured plating is to be cut-out. 2. Internal structures are to be checked. 3. Cut-out is to be closed by an insert plating according to the sketch (welding only from one side is demonstrated). 4. Modification of the radius. 5. In case of a new cast piece, connection with the plating is to be shifted outside the high stress area.

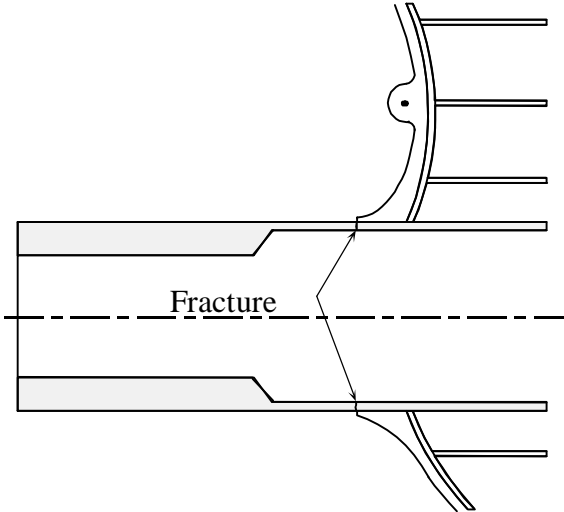
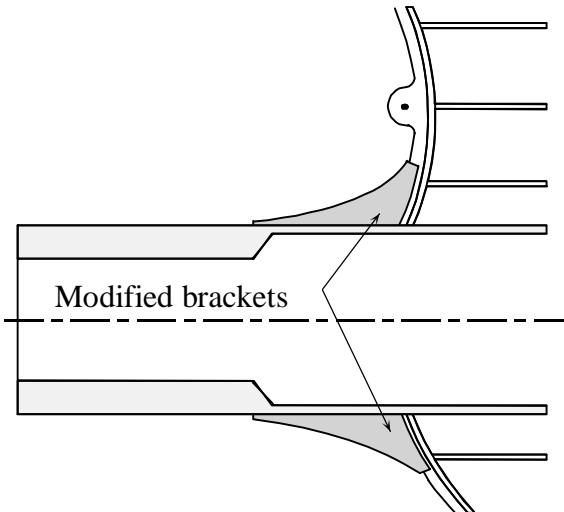
Notes on possible cause of damage		Notes on repairs	
<ol style="list-style-type: none"> 1. Fatigue fracture due to vibration. 		<ol style="list-style-type: none"> 1. Fractured tube is to be veed-out and welded from both sides. 2. Brackets are to be replaced by modified brackets with soft transition.

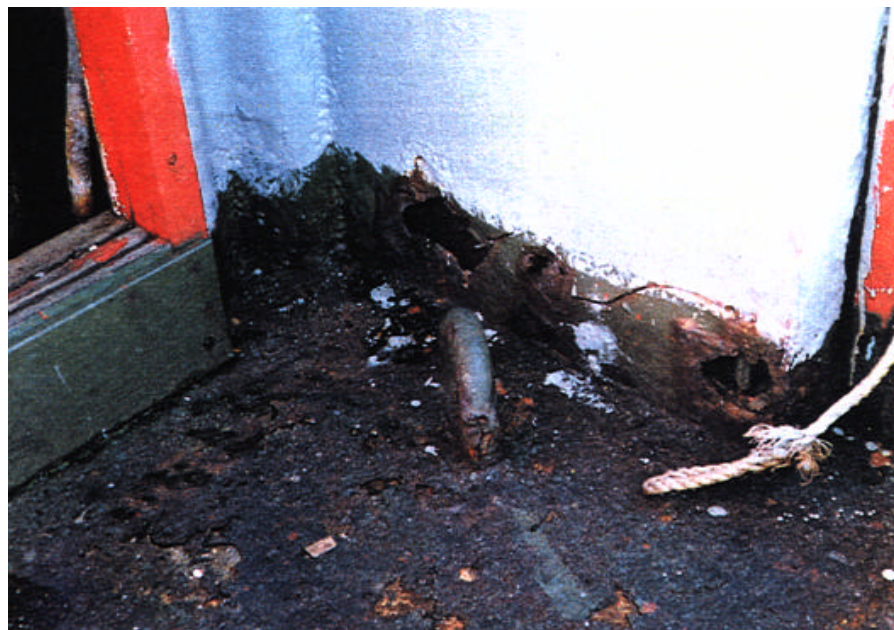
Photograph 1 Corroded accommodation house side structure
