IABMAS2016

8th International Conference on
Bridge Maintenance, Safety and Management
June 26 - 30, 2016 | Foz do Iguaçu | Brazil

First Applications Of Structural Redundancy In Chilean Bridges

Pablo Figueroa. P.E, Universidad de Los Andes

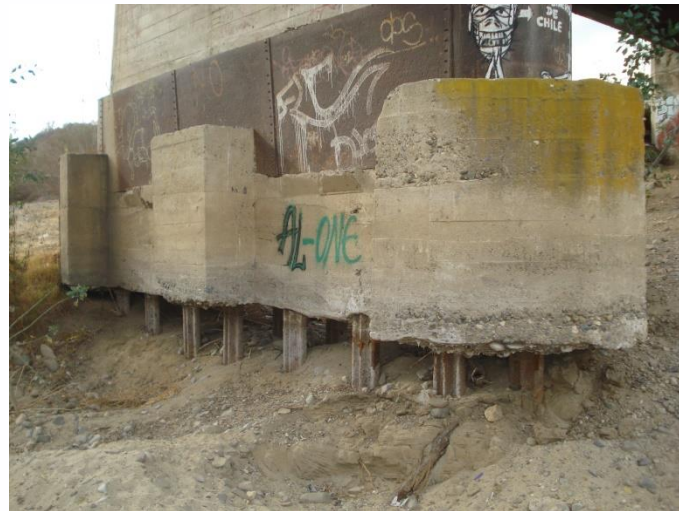
Figure 1. Eroded soil around the pier of the Curacavi Bridge, in Metropolitan Region, Chile.

Relation between seismic loads and scour → Seismic scour hazard (PSS)

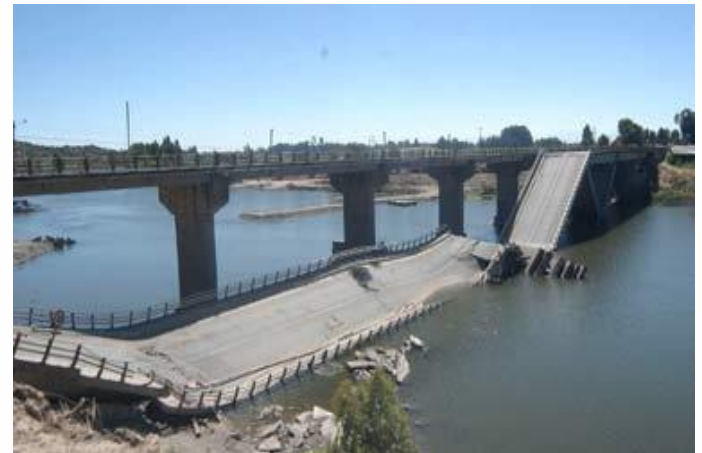
[Figure 2](#). Loncomilla Bridge collapsed due to scour. (Fisco deberá pagar. 2011)

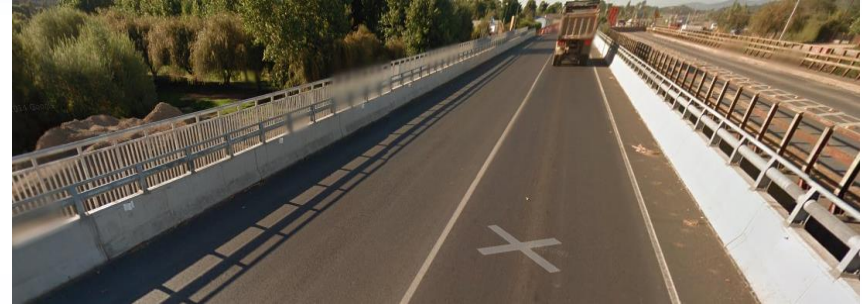
Ramadillas 2 Bridge

Figure 5. Load distribution in the case study.

- Route 160 Concepción – Lebu
- Carampangue river
- Concrete slab. Semi-continuos span
- 4 concrete precast beam
- Total length 280 [m]
- Concrete column piers
- Foudation: Piles (1.2 – 9.5 m)
- width of the deck 12.85 m
- Loads: DD- LL 4000 kgf

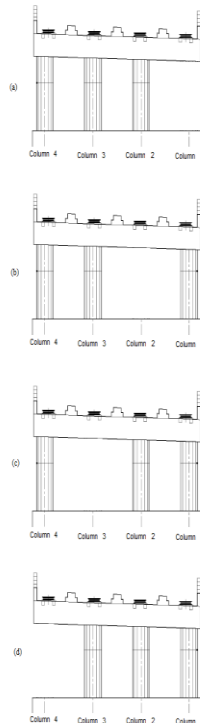
Load application point is located on the cap beam

Load increases perpendicular to the longitudinal axis of the structure.

Control node is located on the opposite side of the cap beam

Plastic hinges were located on every column at 5% and 95% of the column height.
