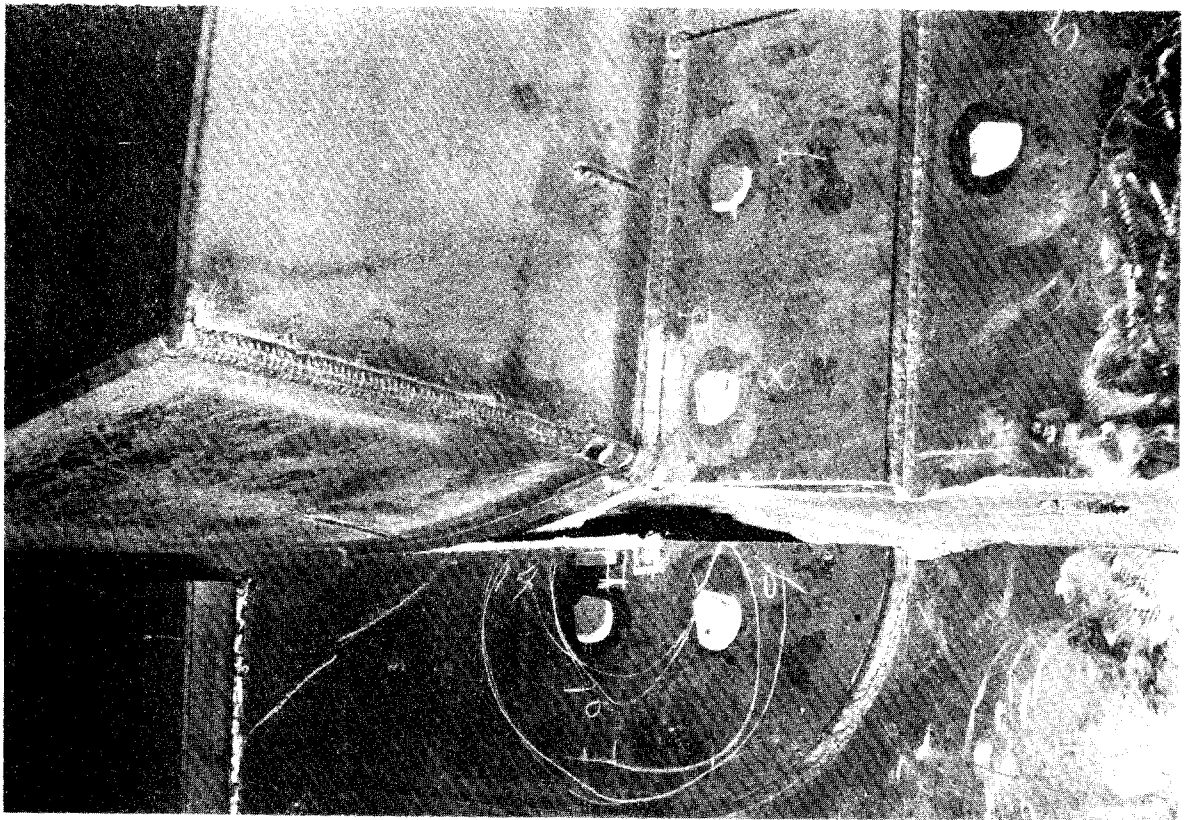
Fractures: Viewed from above deck

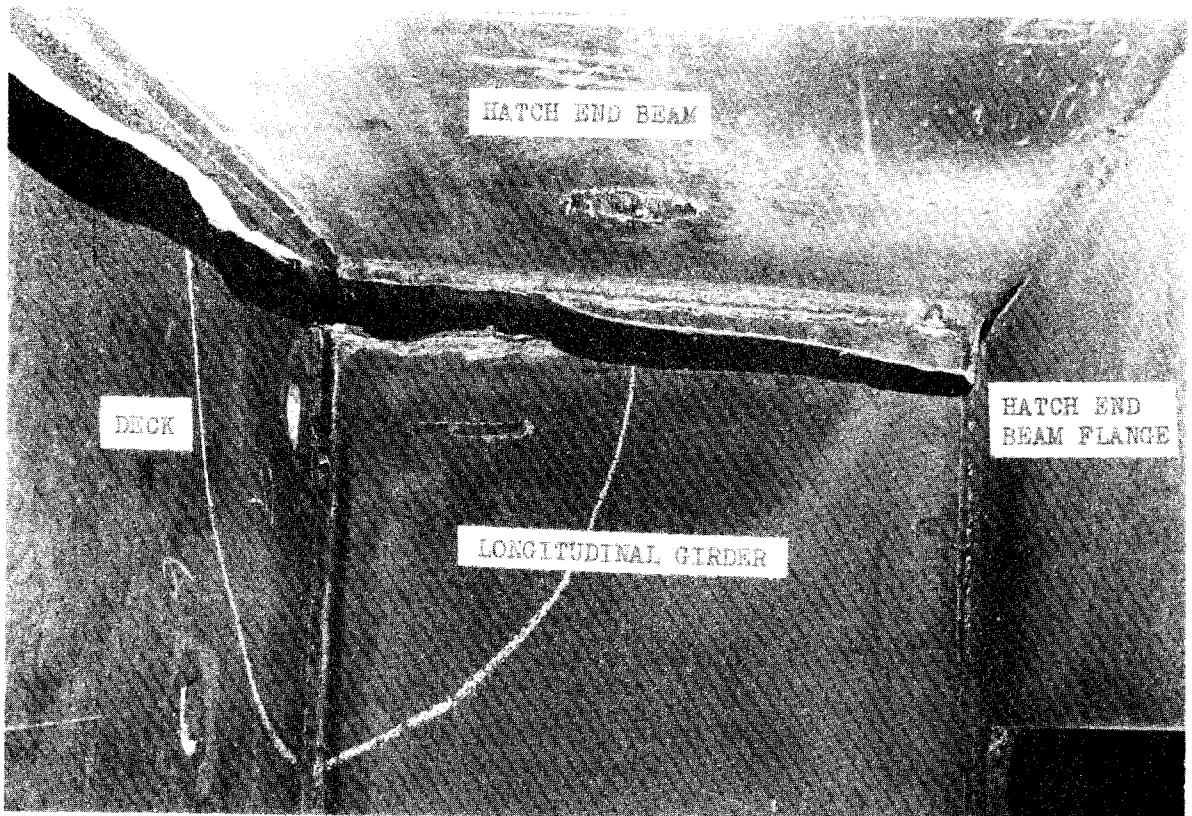
FIG. 21 - SPECIMEN 18

Fractures: Viewed from below deck, outboard, and fwd. of hatch end beam
