No.76 IACS Guidelines for Surveys, Assessment and Repair of Hull Structure - Bulk Carriers

(1994,
Rev.1
June 2001)

**Guidelines for Surveys, Assessment and Repair of Hull
Structure**

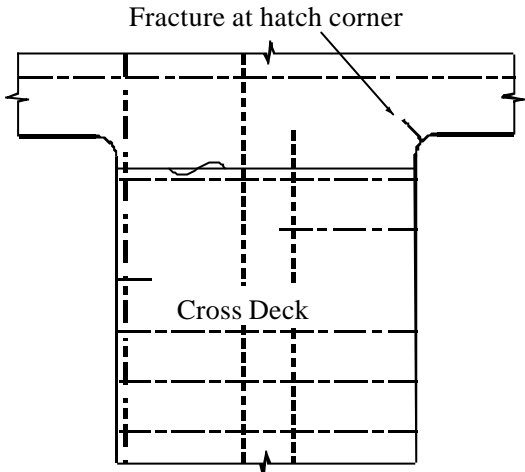
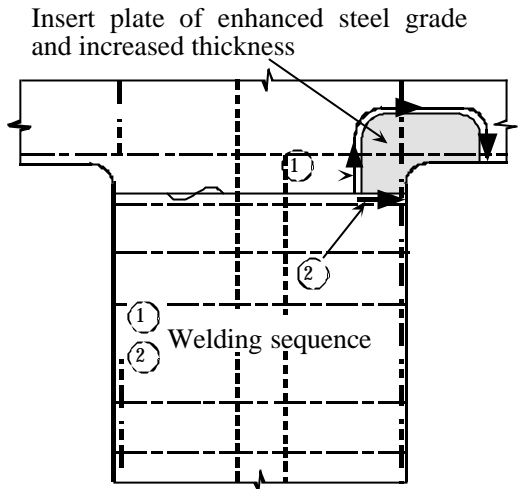
BULK CARRIERS		Guidelines for Surveys, Assessment and Repair of Hull Structure	
Part 1	Cargo hold region	Example No.	
Area 1	Deck structure	1	
Detail of damage		Fractures at main cargo hatch corner	
<p>Sketch of damage</p>

<p>Notes on possible cause of damage</p> <ol style="list-style-type: none"> 1. Stress concentration at hatch corners, i.e. radius of corner. 2. Welded attachment of shedder plate close to edge of hatch corner. 3. Wire rope groove. 		<p>Notes on repairs</p> <ol style="list-style-type: none"> 1. The corner plating in way of the fracture is to be cropped and renewed. If stress concentration is primary cause, insert plate should be increased thickness, enhanced steel grade and/or improved geometry. Insert plate should be continued beyond the longitudinal and transverse extent of the hatch corner radius ellipse or parabola, and the butt welds to the adjacent deck plating should be located well clear of the butts in the hatch coaming. It is recommended that the edges of the insert plate and the butt welds connecting the insert plates to the surrounding deck plating be made smooth by grinding. In this respect caution should be taken to ensure that the micro grooves of the grinding are parallel to the plate edge. 2. If the cause of fracture is welded attachment of shedder plate, the deck connection should be left unwelded. 3. If the cause of the fracture is wire rope groove, replacement to the original design can be accepted.

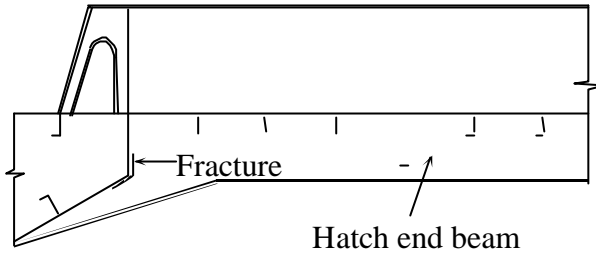
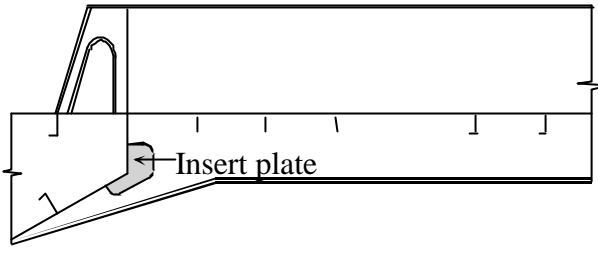
BULK CARRIERS		Guidelines for Surveys, Assessment and Repair of Hull Structure	
Part 1	Cargo hold region	Example No.	
Area 1	Deck structure	8	
Detail of damage		Fractures in hatch end beam at the joint to topside tank	
Sketch of damage		Sketch of repair

Notes on possible cause of damage		Notes on repairs	
<ol style="list-style-type: none"> Misalignment of the hatch end beam with transverse web frame in topside tank. Stress concentration. 		<ol style="list-style-type: none"> Fractured part to be cropped and renewed.

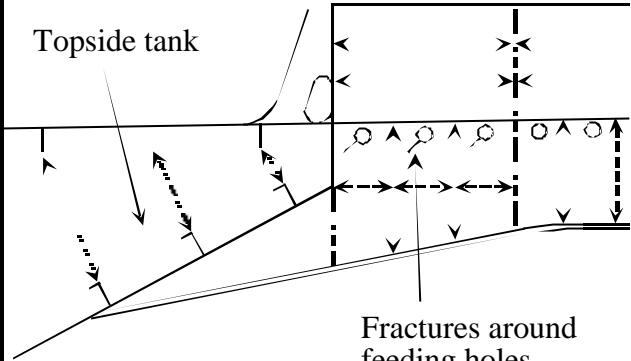
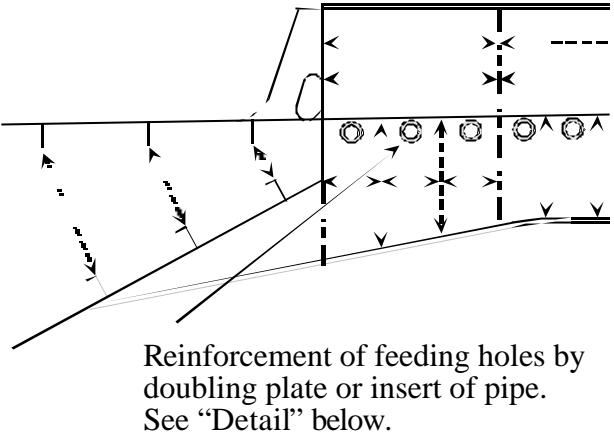
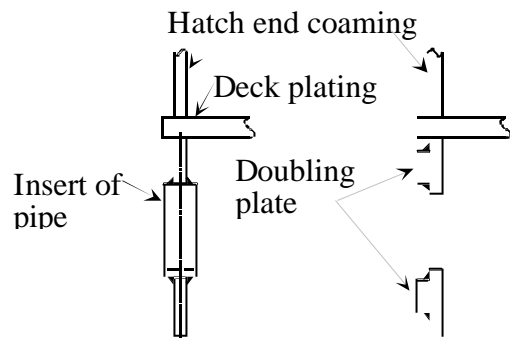
BULK CARRIERS		Guidelines for Surveys, Assessment and Repair of Hull Structure	
Part 1	Cargo hold region	Example No.	
Area 1	Deck structure	9	
Detail of damage		Fractures in hatch end beam around feeding holes	
Sketch of damage		Sketch of repair

<p>Topside tank</p> <p>Fractures around feeding holes</p>

<p>Hatch end coaming</p> <p>Deck plating</p> <p>Insert of pipe</p> <p>Doubling plate</p> <p>Detail</p>	
Notes on possible cause of damage		Notes on repairs	
<ol style="list-style-type: none"> 1. Inadequate reinforcement around feeding hole. 2. Corrosion. 		<ol style="list-style-type: none"> 1. Fractured part to be veed-out or cropped and renewed. 2. If the fractured part is free from corrosion, reinforcement should be considered.

<p>Reinforcement of feeding holes by doubling plate or insert of pipe. See "Detail" below.</p>

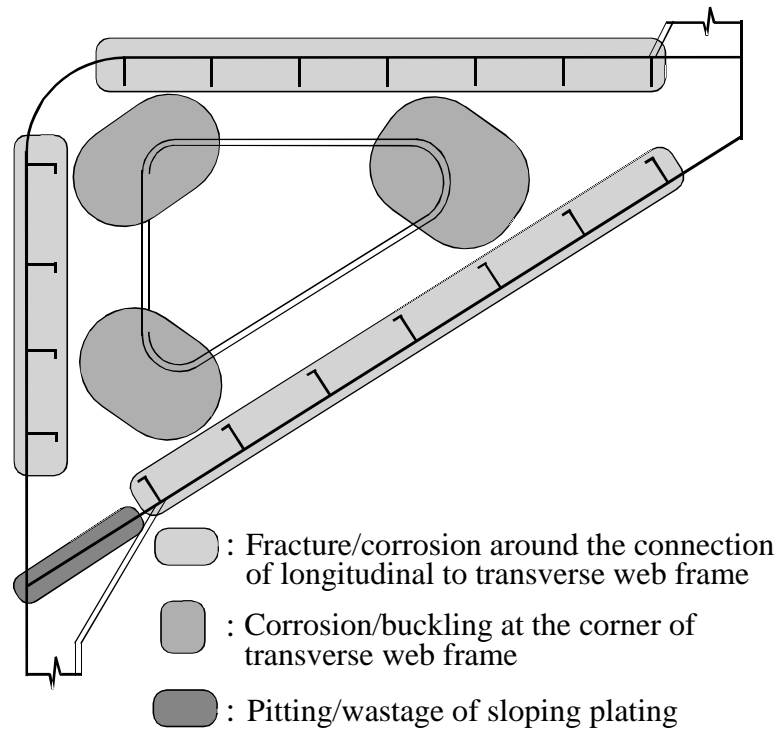
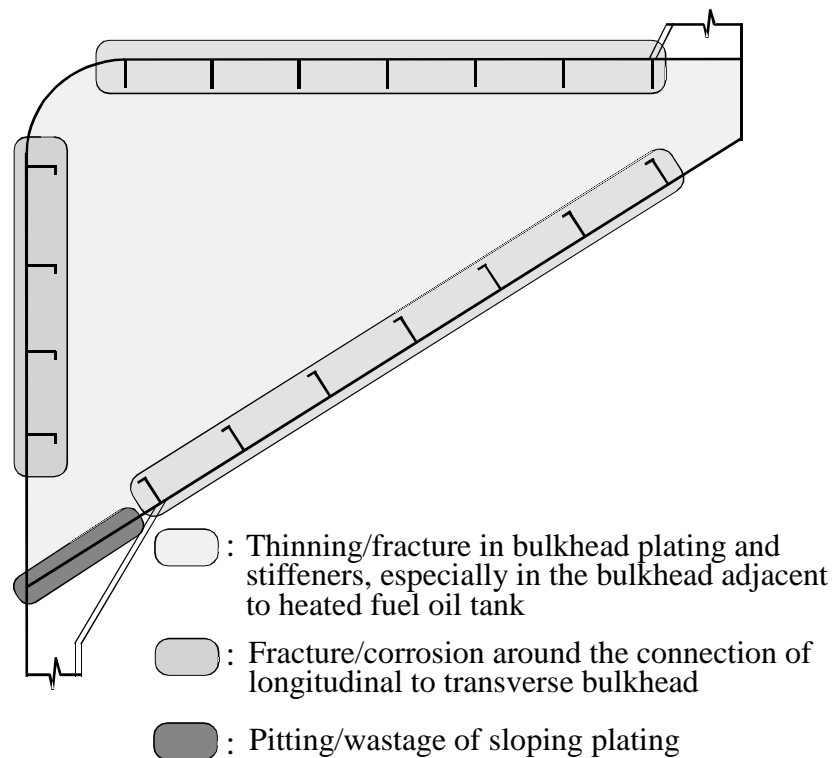
Figure 1 Topside tank - Potential problem areas

- (a) Structure in corrosive environment
 - Deck plating and deck longitudinal
 - Transverse bulkhead adjacent to heated fuel oil tank
 - Lowest part of sloping plating
- (b) Structure subject to high stress
 - Face plates and web plates of transverse at corners
 - Connection of side longitudinal to transverse
- (c) Areas susceptible to coating breakdown
 - Back side of face plate of longitudinal
 - Welded joint
 - Edge of access opening
- (d) Areas subjected to poor drainage
 - Web of side and sloping longitudinals

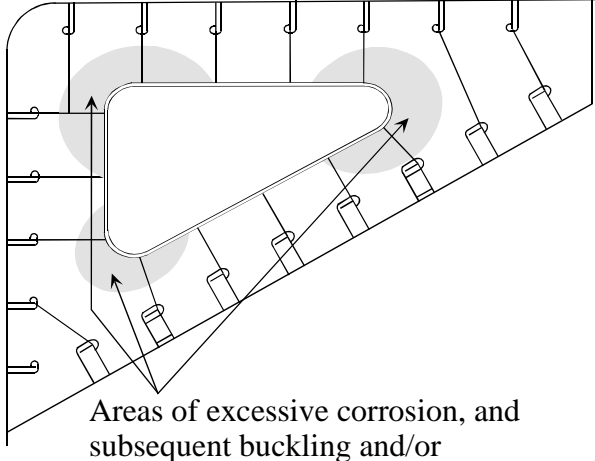
BULK CARRIERS		Guidelines for Surveys, Assessment and Repair of Hull Structure	
Part 1	Cargo hold region	Example No.	
Area 2	Topside tank structure	2-a	
Detail of damage	Thinning and subsequent buckling of web plating in the vicinity of the radii of the opening		
Sketch of damage		Sketch of repair

<p>Areas of excessive corrosion, and subsequent buckling and/or</p>

<p>Additional stiffeners</p>	
Notes on possible cause of damage		Notes on repairs	
<ol style="list-style-type: none"> 1. Insufficient buckling strength. 2. Corrosion due to stress concentration at corners. 		<ol style="list-style-type: none"> 1. Buckled plating is to be cropped and parts renewed, if necessary. 2. Additional stiffeners as shown above and/or renewal with plating of increased thickness should be considered.

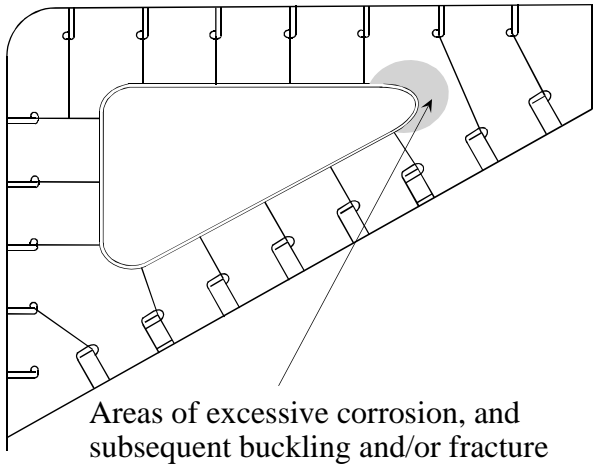
BULK CARRIERS		Guidelines for Surveys, Assessment and Repair of Hull Structure	
Part 1	Cargo hold region	Example No.	
Area 2	Topside tank structure	2-b	
Detail of damage	Thinning and subsequent buckling of web plating in the vicinity of the radii of the opening		
Sketch of damage		Sketch of repair

<p>Areas of excessive corrosion, and subsequent buckling and/or fracture</p>

<p>Enlarged radius of the opening</p>	
Notes on possible cause of damage		Notes on repairs	
<ol style="list-style-type: none"> 1. Corrosion caused by stress concentration at the corner due to insufficient radius for the opening. 		<ol style="list-style-type: none"> 1. Corroded/buckled plating is to be cropped and parts renewed with plating of increased thickness and additional stiffeners are preferable to minimize deflection. 2. An attempt should be made to improve the design of the radius if felt necessary.

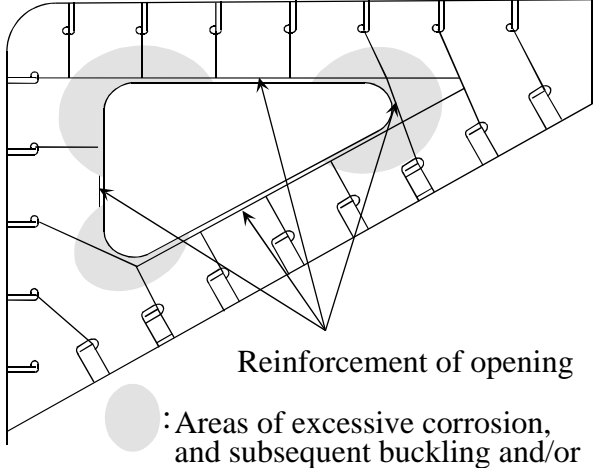
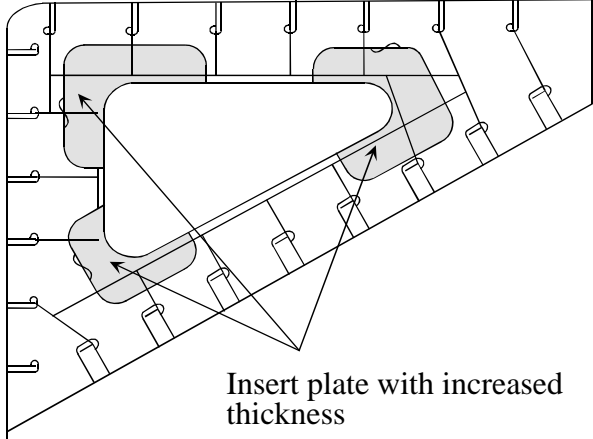
BULK CARRIERS		Guidelines for Surveys, Assessment and Repair of Hull Structure	
Part 1	Cargo hold region		Example No.
Area 2	Topside tank structure		2-c
Detail of damage		Thinning and subsequent buckling of web plating in the vicinity of the radii of the opening	
Sketch of damage		Sketch of repair

<p>Reinforcement of opening</p> <p>: Areas of excessive corrosion, and subsequent buckling and/or</p>

<p>Insert plate with increased thickness</p>	
Notes on possible cause of damage		Notes on repairs	
<p>1. Additional stresses at the free edge of transverse web. (In Example 2-a - 2-c face plate is provided for the reinforcement of the opening.)</p>		<p>1. Corroded/buckled plating is to be cropped and part renewed with plating of increased thickness.</p>

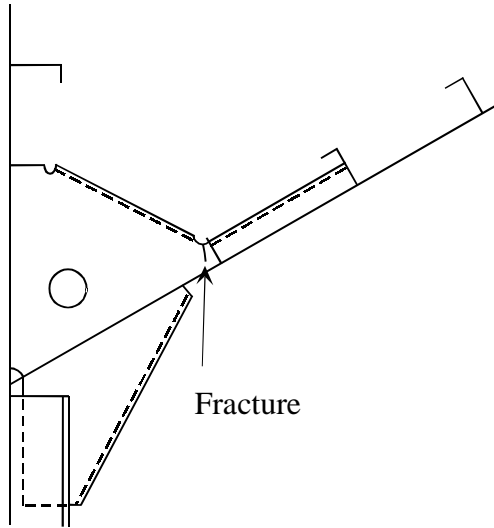
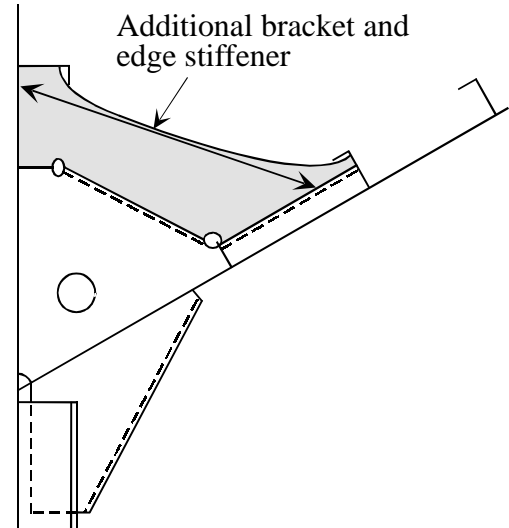
BULK CARRIERS		Guidelines for Surveys, Assessment and Repair of Hull Structure	
Part 1	Cargo hold region	Example No.	
Area 2	Topside tank structure	7-c	
Detail of damage		Fractures at toes of transverse bracket	
Sketch of damage		Sketch of repair

Notes on possible cause of damage		Notes on repairs	
<p>1. Stress concentration due to the shape of the bracket.</p>		<p>1. Cracked weld to be veed-out and rewelded.</p>

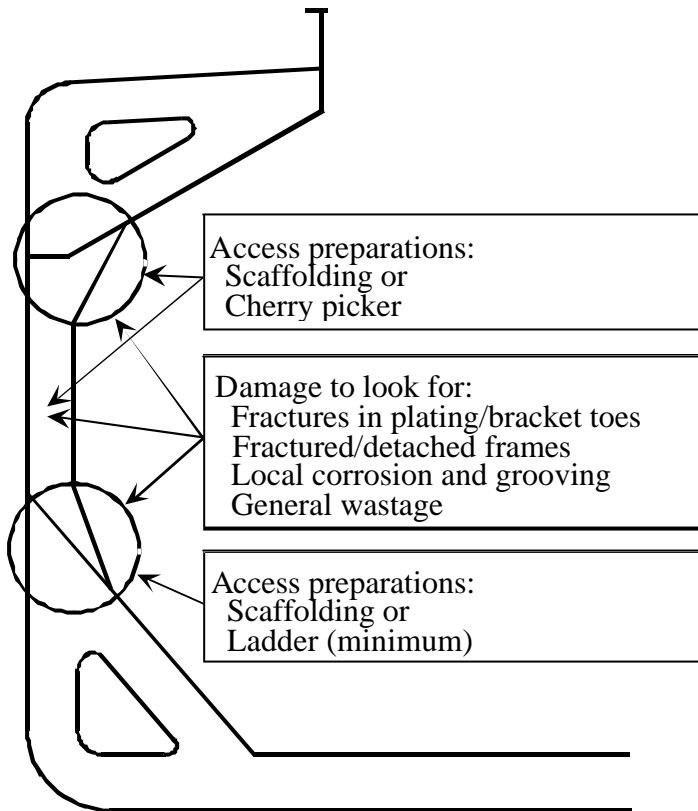
Figure 1
Side shell frame - Potential problem areas

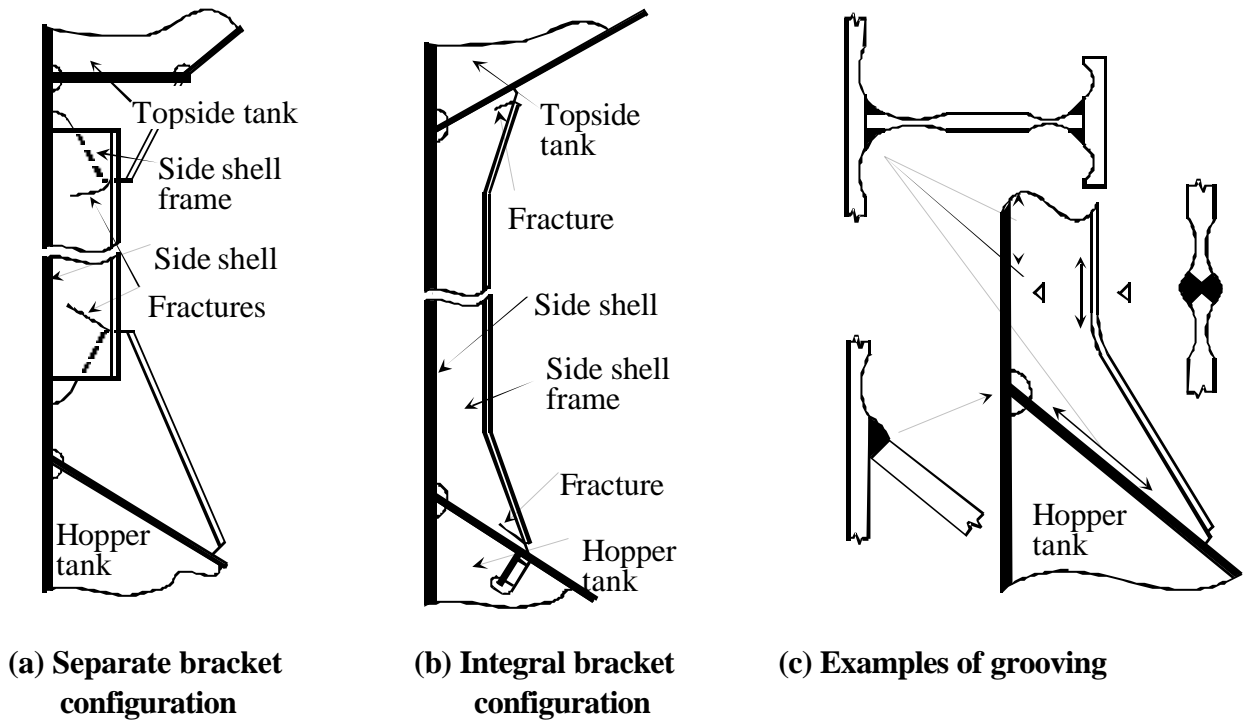
Figure 2 Damages to side shell frame - Potential problem areas

(Note) The type of bracket configuration used will, to a large extent, dictate the location and extent of fracture. Where separate brackets are employed, the fracture location is normally at the bracket toe position on the frames, whereas with integral brackets the location is at the toe position on the hopper and topside tank.

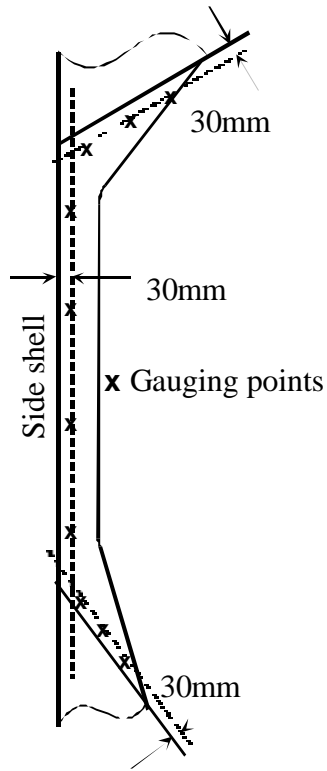
Figure 3
Representative gauging locations on the side shell frame - Potential problem areas

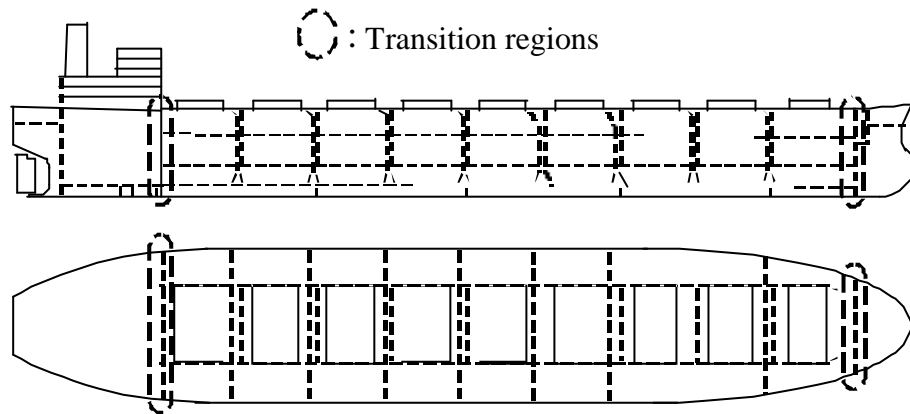
- 1.5** The structure at the transition regions at the fore and aft ends of the ship are subject to stress concentrations due to structural discontinuities. The side shell plating at the transition regions is also subject to panting. The lack of continuity of the longitudinal structure, and the increased slenderness and flexibility of the side structure, makes the structure at the transition regions more prone to fracture damages.

Figure 4 **Transition regions - Potential problem area**

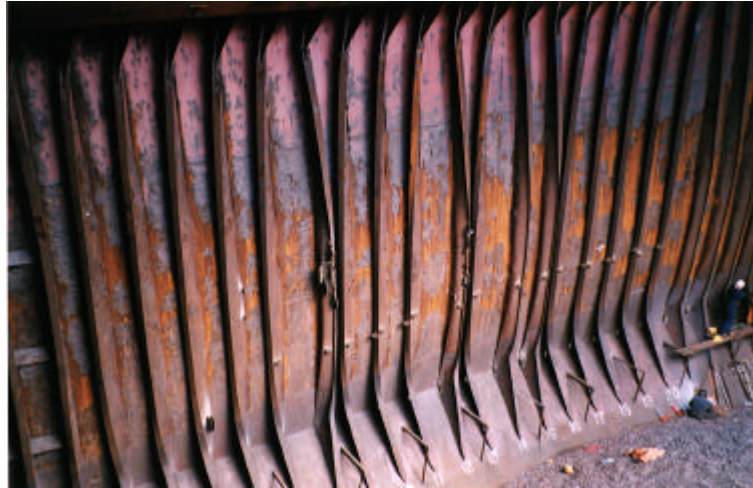
Photograph 1 Collapsed side shell frames (See Example 4)

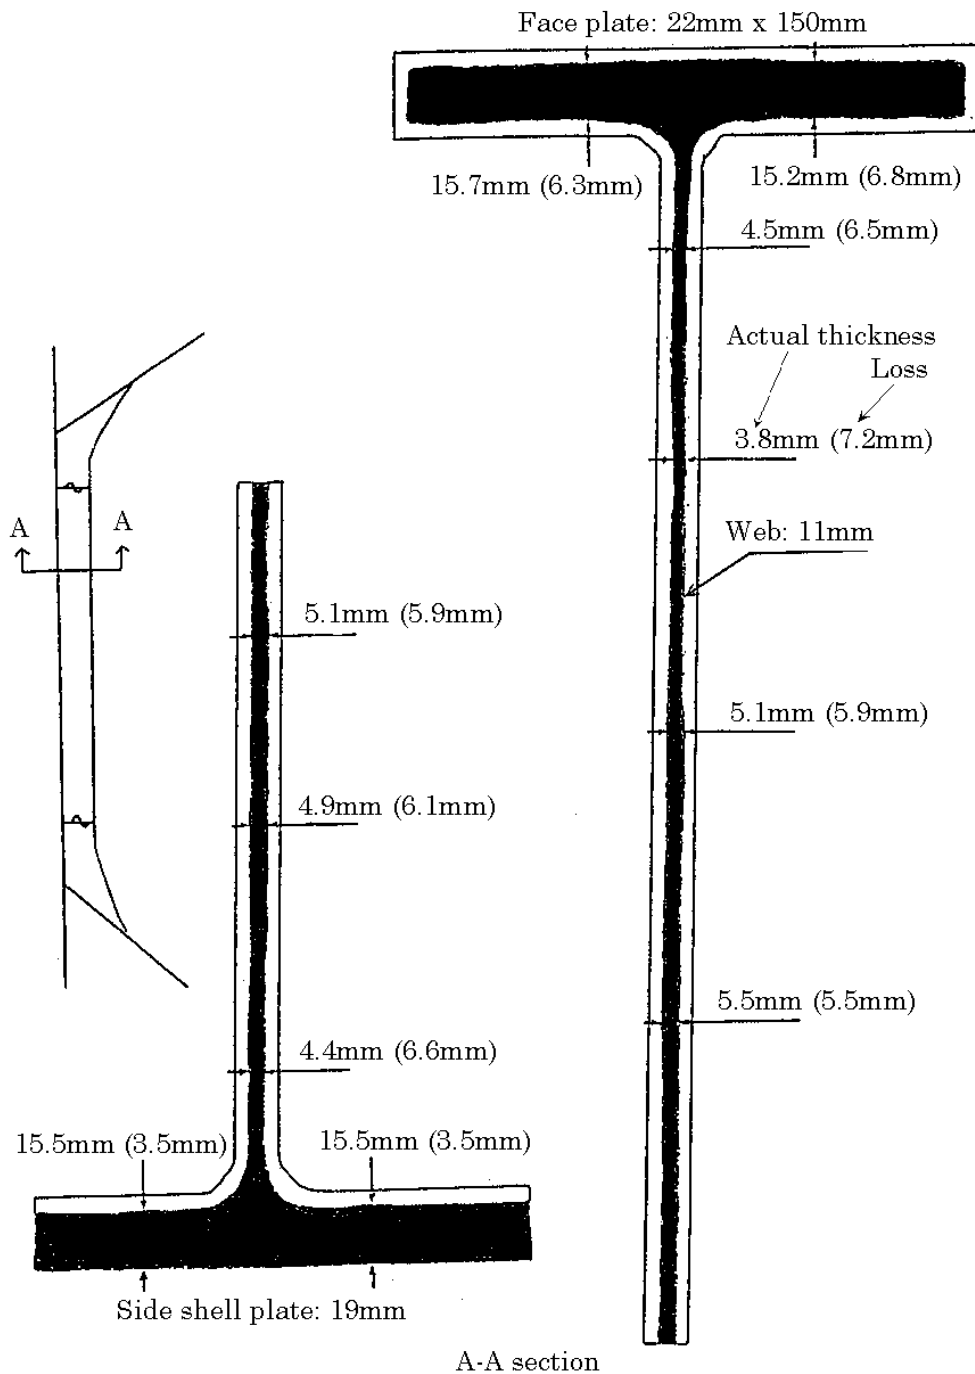
- 2.1.1** Attention is drawn to the fact that side shell frames may be significantly weakened by loss of thickness although diminution and deformations may not be apparent. Inspection should be made after the removal of any scale or rust deposit. Thickness measurements may be necessary, particularly if the corrosion is smooth and uniform, to determine the condition of the structure (See **Figure 5**).

Figure 5 Uniform corrosion of side shell frame

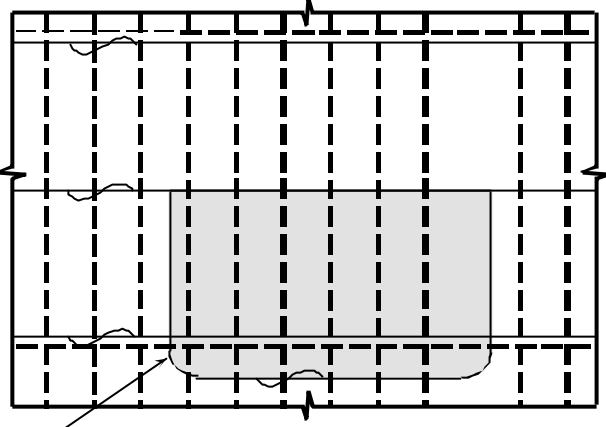
<p>Topside tank sloping plating</p> <p>Side shell frame</p> <p>Hopper tank sloping plating</p> <p>Fracture in side shell plating along side shell frame and hopper tank sloping plating</p>

<p>Part renewal including side shell frames and hopper sloping plating, as found necessary</p>	
Notes on possible cause of damage		Notes on repairs	
<ol style="list-style-type: none"> 1. Heavy corrosion (grooving). Refer to Figure 2 (c). 		<ol style="list-style-type: none"> 1. Sketch of repair applies when damage extends over several frames. 2. Isolated fractures may be repaired by veeing-out and rewelding. 3. Isolated cases of grooving may be repaired by build up of welding.

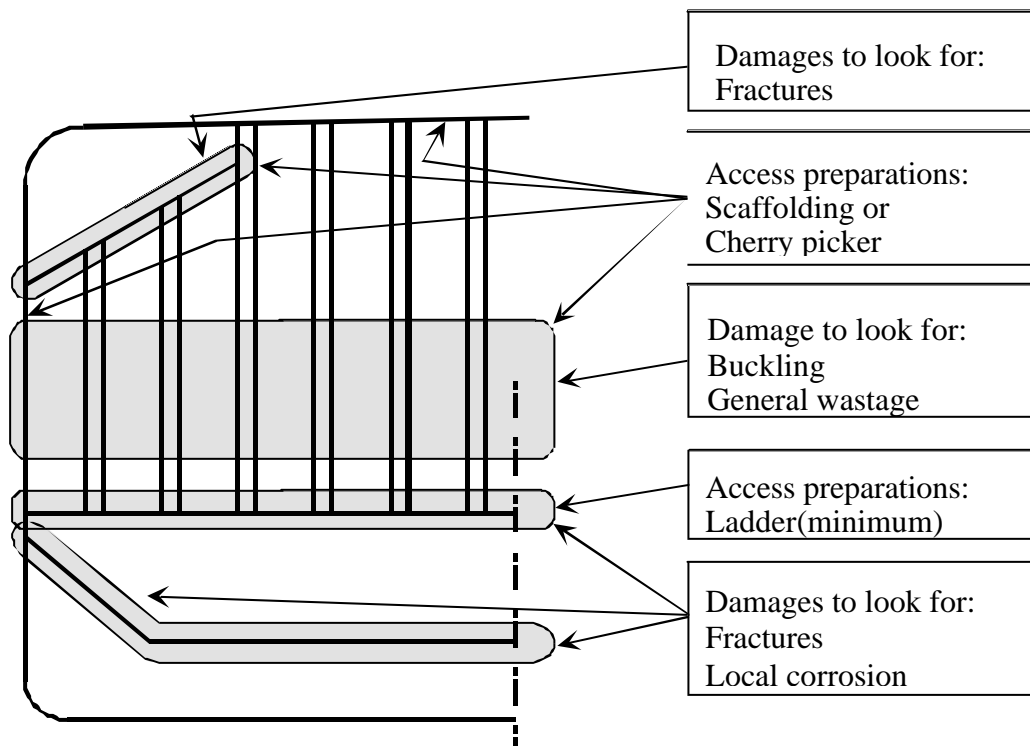
Figure 1 **Transverse bulkhead - Potential problem areas**

- (a) At the mid-height and at the bottom of the bulkheads. The structure may look in deceptively good condition but in fact may be heavily corroded. The corrosion is created by the corrosive effect of cargo and environment, in particular when the structure is not coated.
- (b) Bulkhead plating adjacent to the shell plating
- (c) Bulkhead trunks which form part of the venting, filling and discharging arrangements between the topside tanks and the hopper tanks.
- (d) Bulkhead plating and weld connections to the lower/upper stool shelf plates and inner bottom.
- (e) In way of weld connections to topside tanks and hopper tanks.

2.2.2 When the bulkhead has sustained serious uniform corrosion, the bulkhead may suffer shear buckling. Evidence of buckling may be indicated by the peeling of paint or rust. However, where deformation resulting from bending or shear buckling has occurred on a bulkhead with a small diminution in thickness, this could be due to poor design or overloading and this aspect should be investigated before proceeding with repairs.

4.2.2 Buckling of the bulkhead plating can also occur in way of the side shell resulting from contact damage and this is usually quite obvious. In such cases the damaged area is to be cropped and partly renewed. If the deformation is extensive, replacement of the plating, partly or completely, may be necessary. If the deformation is not in association with generalized reduction in thickness or due to excessive loading, additional strengthening should be considered.

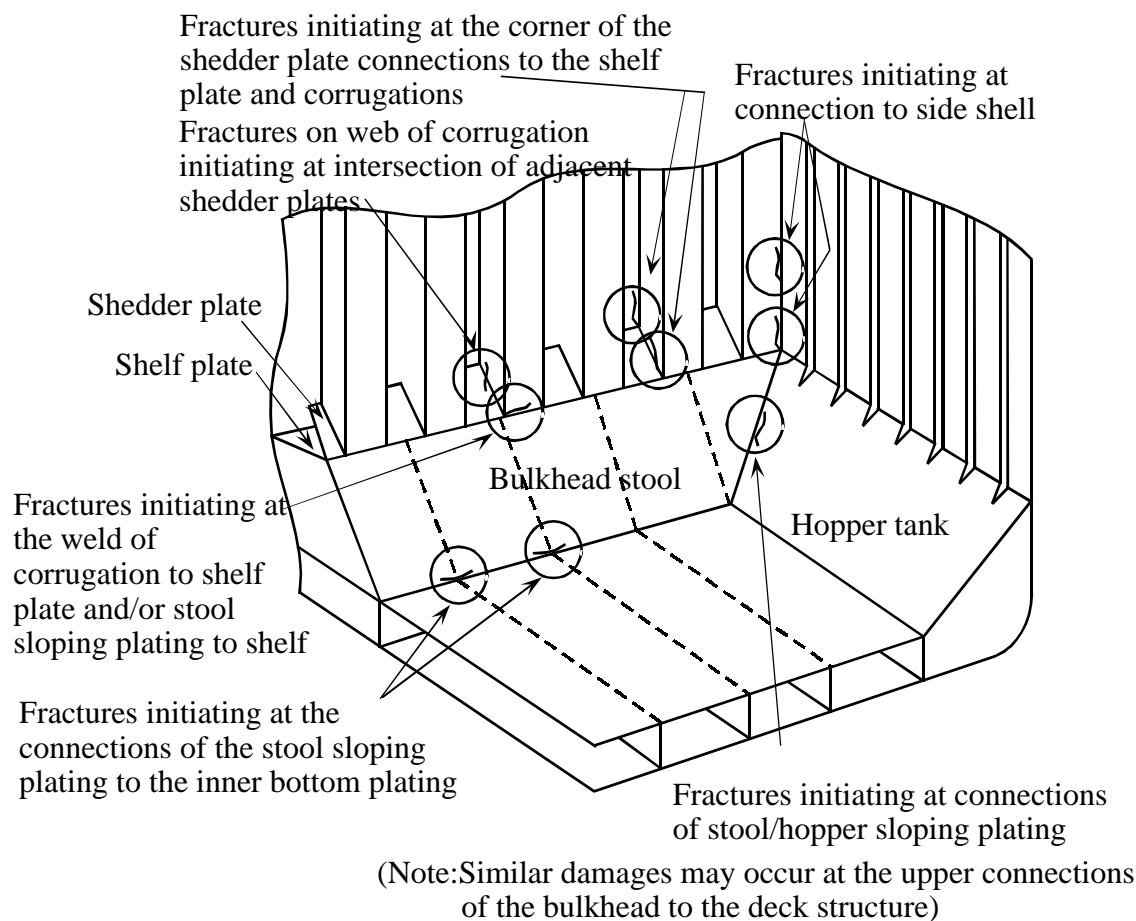
Figure 2 Typical fracturing at the connection of transverse bulkhead structure

2.3.1 Fractures usually occur at the boundaries of corrugations and bulkhead stools particularly in way of shelf plates, shedder plates, deck, inner bottom, etc. (See **Figure 2**).

4.3.1 Fractures that occur at the boundary weld connections as a result of latent weld defects should be veed-out, appropriately prepared and re-welded preferably using low hydrogen electrodes or equivalent.

4.3.2 For fractures other than those described in **4.3.1**, re-welding may not be a permanent solution and an attempt should be made to improve the design and construction in order to obviate a recurrence. Typical examples of such cases are as follows:

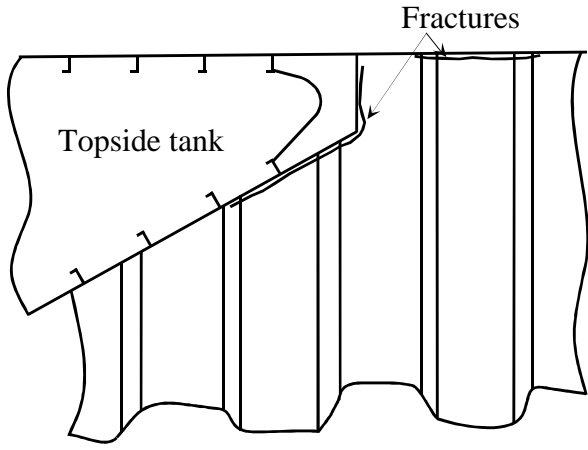
BULK CARRIERS		Guidelines for Surveys, Assessment and Repair of Hull Structure	
Part 1	Cargo hold region	Example No.	
Area 4	Transverse bulkhead and associated structure in cargo hold	2	
Detail of damage		Fractures at the upper boundaries to topside tanks	
Sketch of damage		Sketch of repair

<p>The sketch shows a cross-section of a hull structure with a topside tank on the left and vertical stiffeners on the right. Arrows point to the upper boundary of the tank where fractures have occurred. Labels include 'Topside tank' and 'Fractures'.</p>		<p>Continuous or intercostal reinforcement in line with flanges or gussets where not already fitted</p> <p>Adjacent to the topside tank either a gusset to a bulb plate stiffener may be</p>

Notes on possible cause of damage		Notes on repairs	
<ol style="list-style-type: none"> 1. Damage due to poor design and/or defective welds. 		<ol style="list-style-type: none"> 1. Fractures may be veed-out and rewelded. If necessary corrugated plating cropped and renewed. 2. It is recommended that reinforcement as shown above be incorporated, giving due consideration to the following criteria: <ol style="list-style-type: none"> 2.1 It is important to have the gusset plates well aligned with the transverse structure inside the tank. Gusset plates may be joggled to obtain this alignment. 2.2 If there is no transverse web already existing inside the topside tank and in line with the flanges of corrugation or gusset plates, reinforcement as shown above to be fitted.

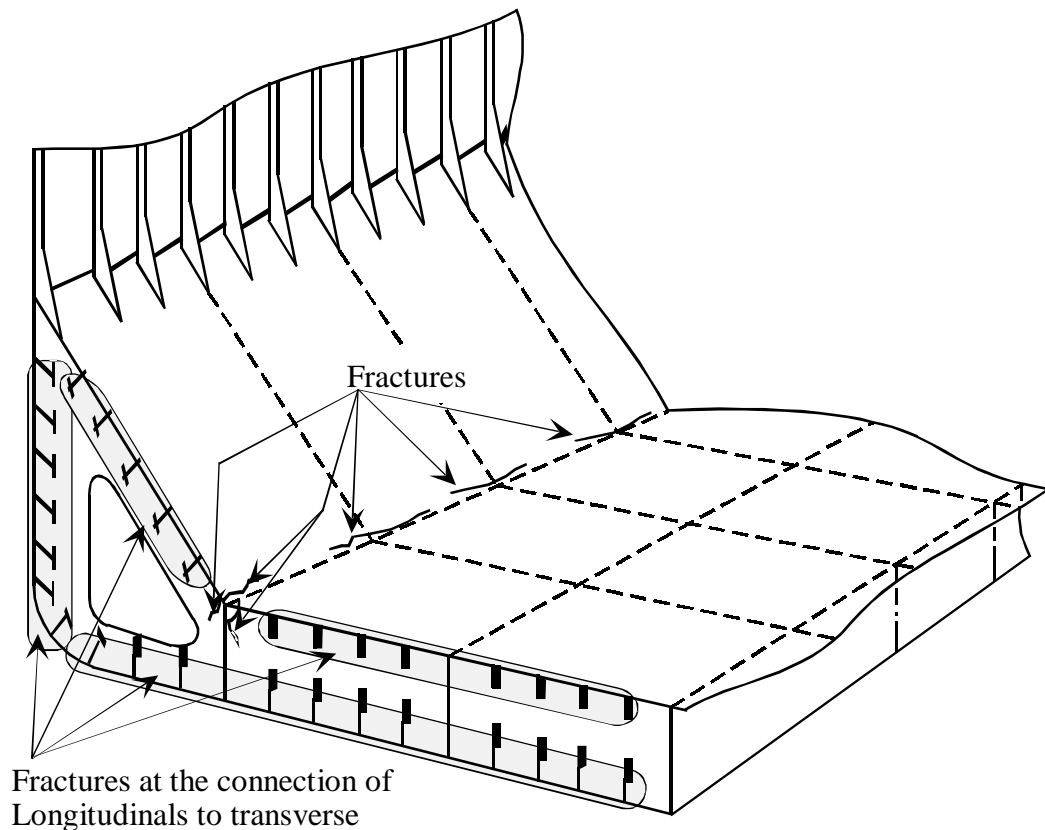
Figure 1 Typical fractures in the connection of hopper sloping plating to inner bottom (tank top) and longitudinals to transverse (or transverse bulkhead)

extend through the thickness of the plating or through the welds may be observed during pressure testing of the double bottom tanks (See **Figure 1** and **2** of **Area 4**).

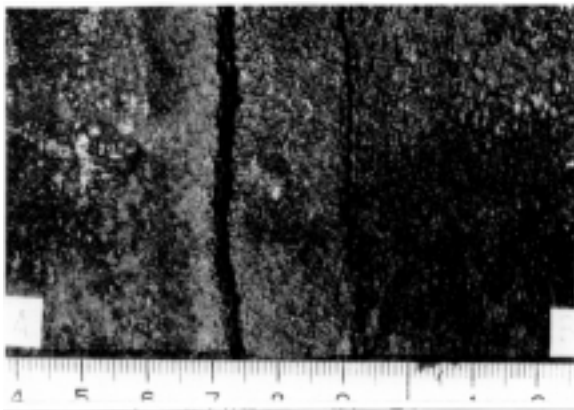
4.1.2 Severe grooving along welding of bottom plating is often found (See **Photographs 1** and **2**). This grooving can be accelerated by poor maintenance of the protective coating and/or sacrificial anodes fitted to the bottom plating.

Photograph 1
Grooving corrosion of welding of bottom plating

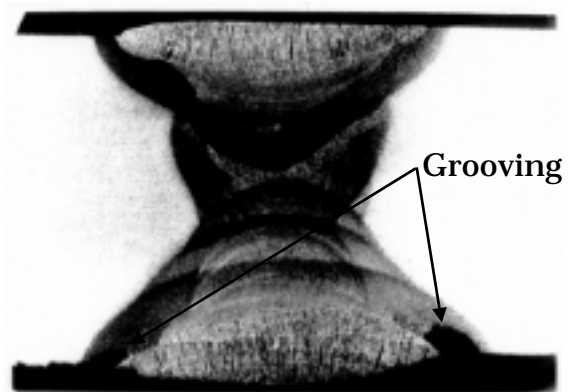
Photograph 2
Section of the grooving shown in Photograph 1

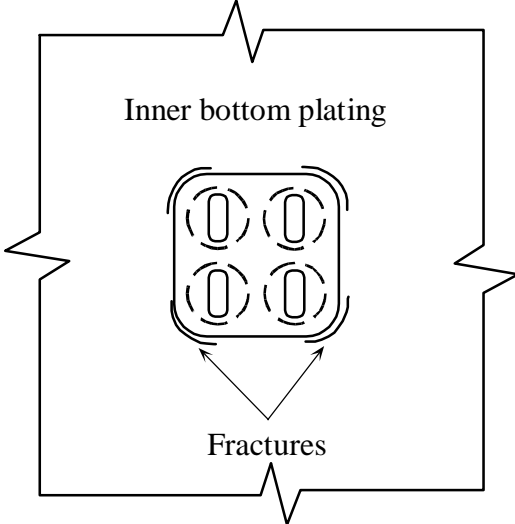
BULK CARRIERS		Guidelines for Surveys, Assessment and Repair of Hull Structure	
Part 1	Cargo hold region	Example No. 1	
Area 5	Double bottom structure including hopper	1	
Detail of damage		Fractures in inner bottom plating around container bottom pocket	
<p>Sketch of damage</p>

<p>Notes on possible cause of damage</p> <ol style="list-style-type: none"> 1. Pocket is not supported correctly by floor, longitudinal and/or stiffener. 		<p>Notes on repairs</p> <ol style="list-style-type: none"> 1. Fractured plating should be cropped and part renewed. 2. Adequate reinforcement should be considered.

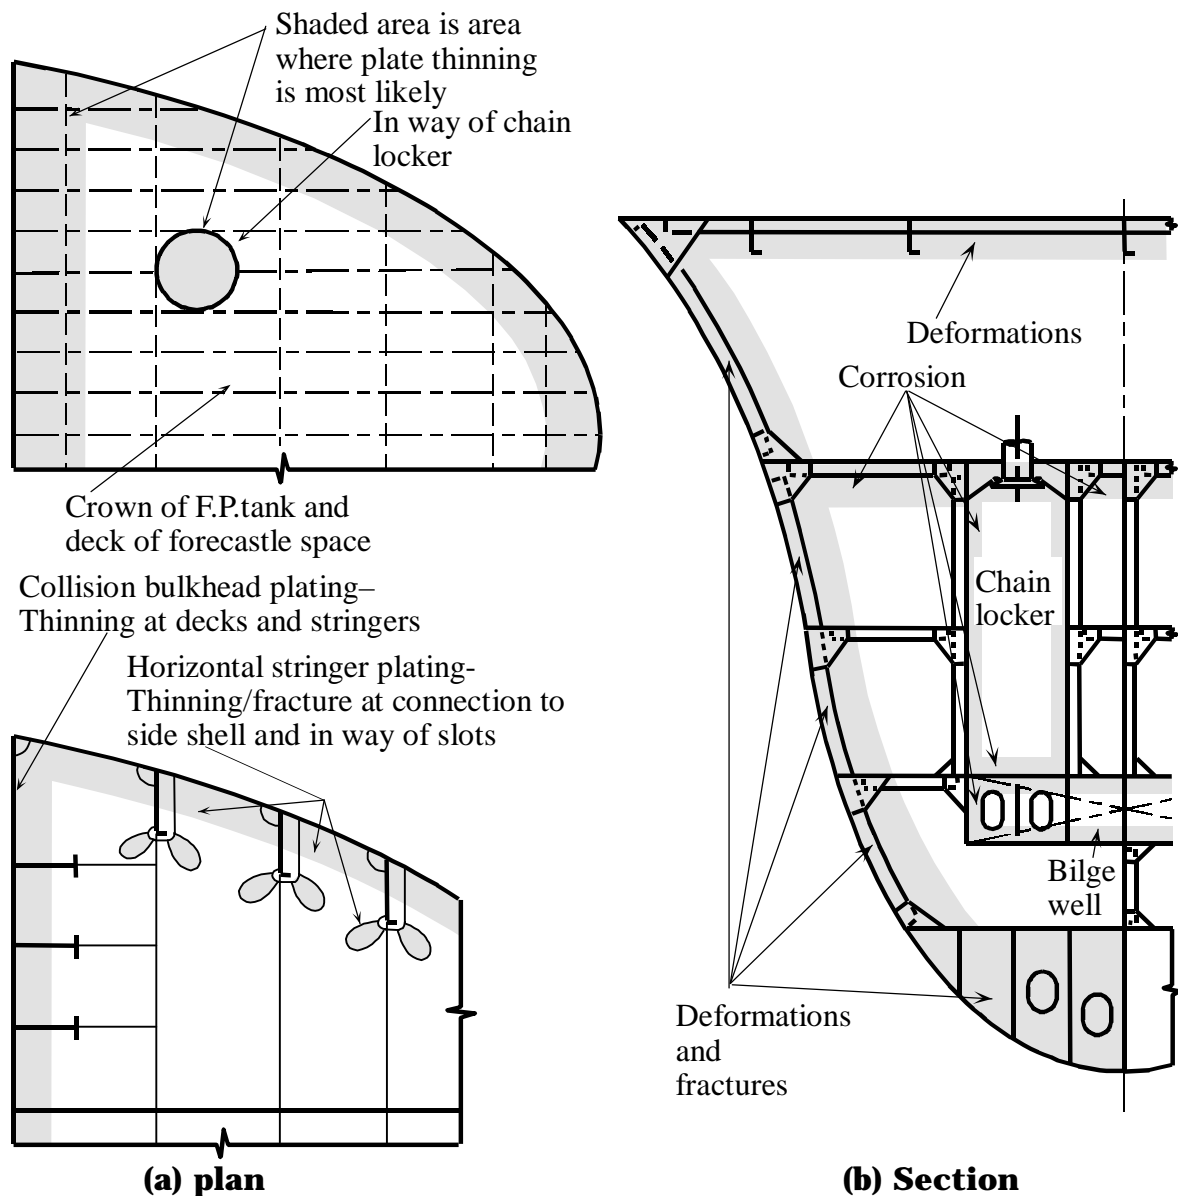
Fig 1 Fore end structure - Potential problem areas

- 2.3.1 Fractures in the fore peak tank are normally found by close-up inspection of the internal structure.
- 2.3.2 Fractures are often found in transition region and reference should be made to **Part 1, Area 2** and **3**.

2.3.3 Fractures that extend through the thickness of the plating or through the boundary welds may be observed during pressure testing of tanks.

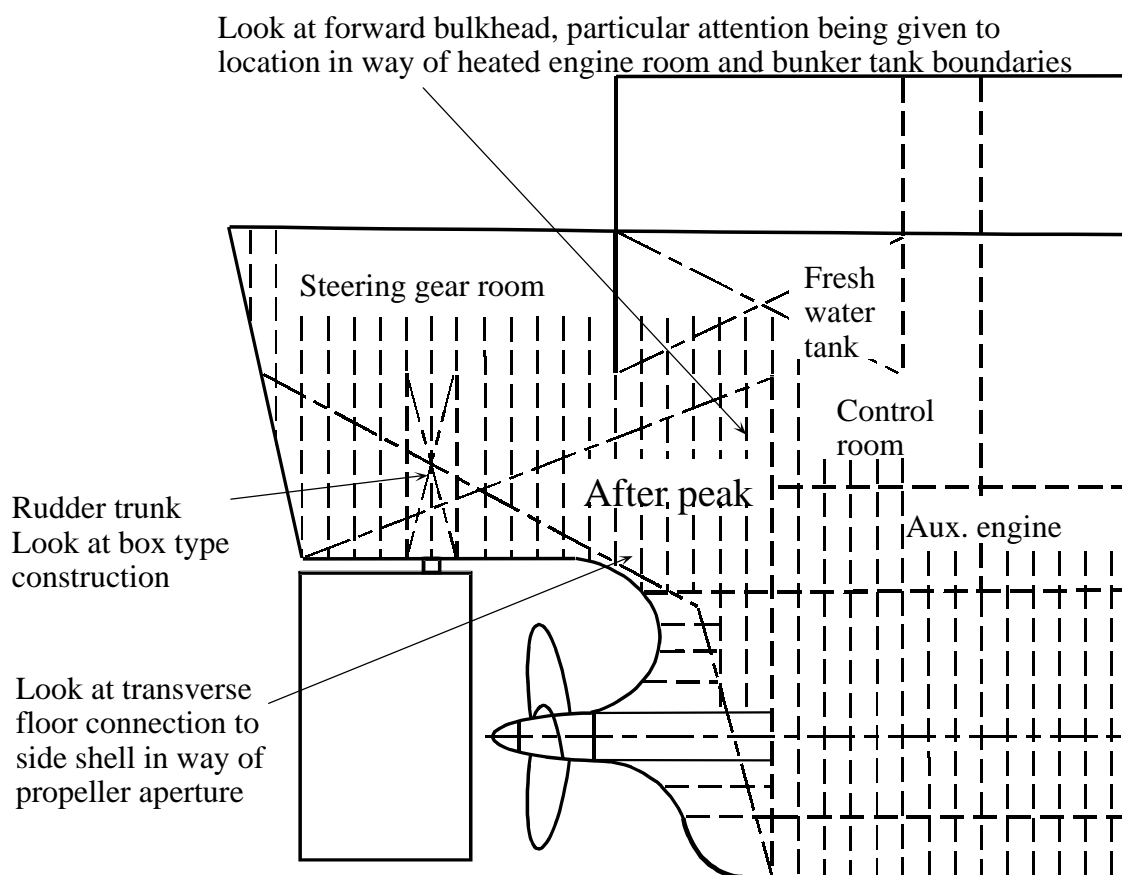
Figure 1 Aft end structure - Potential problem areas

- 2.3.1 Fractures in weld at floor connections and other locations in the aft peak tank and rudder trunk space can normally only be found by close-up inspection.
- 2.3.2 The structure supporting the rudder carrier may fracture and/or deform due to excessive load on the rudder. Bolts connecting the rudder carrier to the steering gear flat may also suffer damage under such load.

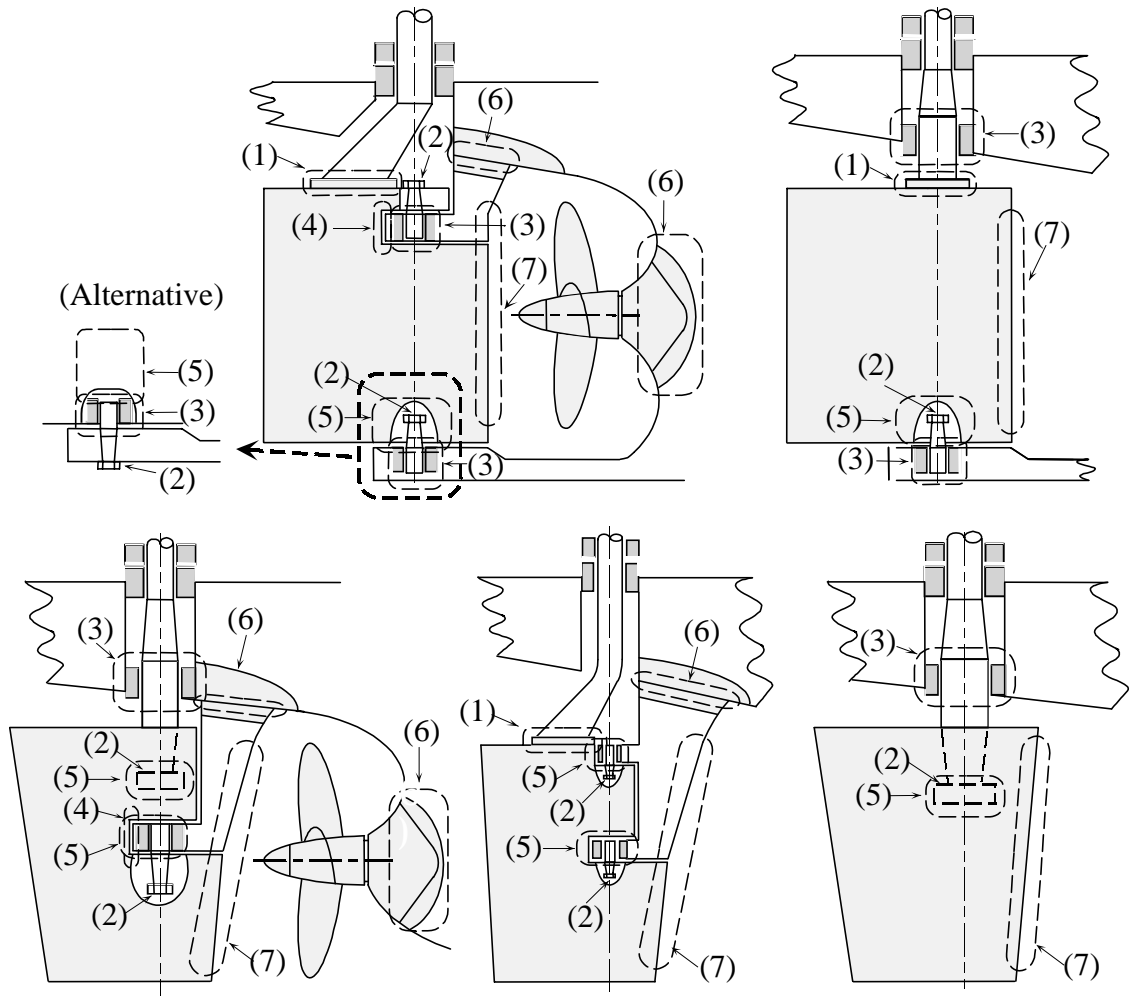
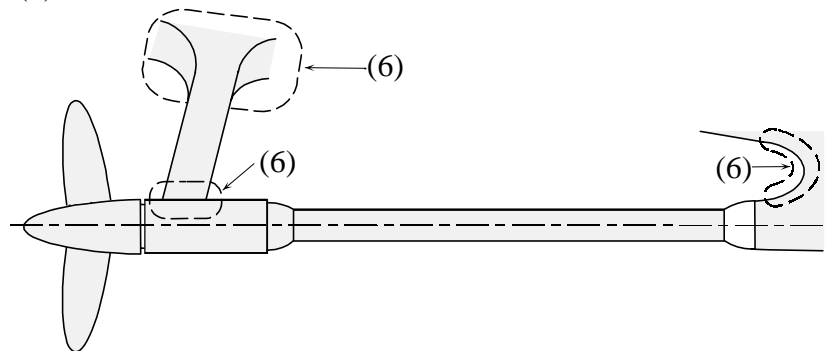
Figure 2 Potential problem areas

- (1) Fractures and loose coupling bolts
- (2) Loose nut
- (3) Wear (excessive bearing clearance)
- (4) Fractures in way of pintle cutout
- (5) Fractures in way of removable access plate
- (6) Fractures
- (7) Erosion

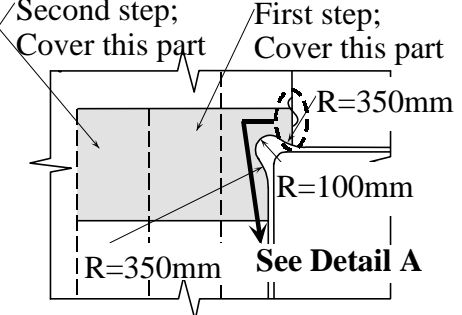
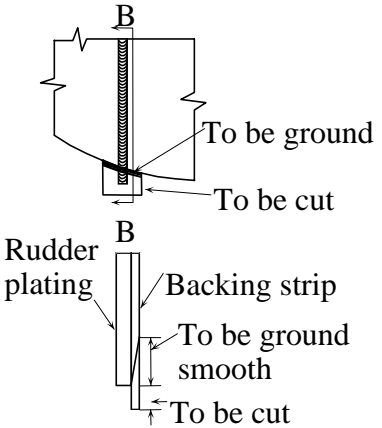
<p>Fracture</p> <p>Fracture B; In weld</p> <p>Fracture A; In plating</p> <p>Rudder horn</p>

<p>To be ground</p> <p>To be cut</p> <p>Rudder plating</p> <p>Backing strip</p> <p>To be ground smooth</p> <p>To be cut</p> <p>View B - B</p>	
Notes on possible cause of damage		Notes on repairs	
<ol style="list-style-type: none"> Inadequate design for stress concentration in way of pintle bearing (Fracture A). Imperfection in welding seam (Fracture B). 		<ol style="list-style-type: none"> Fractured part to be cropped off. Repair by two insert plates of modified, stress releasing contour. For the vertical seam no backing strip is used 100mm off contour, welding from both sides, to be ground after welding. Variant (See Detail A): Repair as mentioned under 2 with the use of backing strip for the complete vertical seam. After welding backing strip partly removed by grinding.

<p>Second step; Cover this part</p> <p>First step; Cover this part</p> <p>R=350mm</p> <p>R=100mm</p> <p>See Detail A</p> <p>Note: 1.R should be considered according to local detail 2.New contour should be ground smooth</p>
