FIGURE 9 - SPECIMEN 14

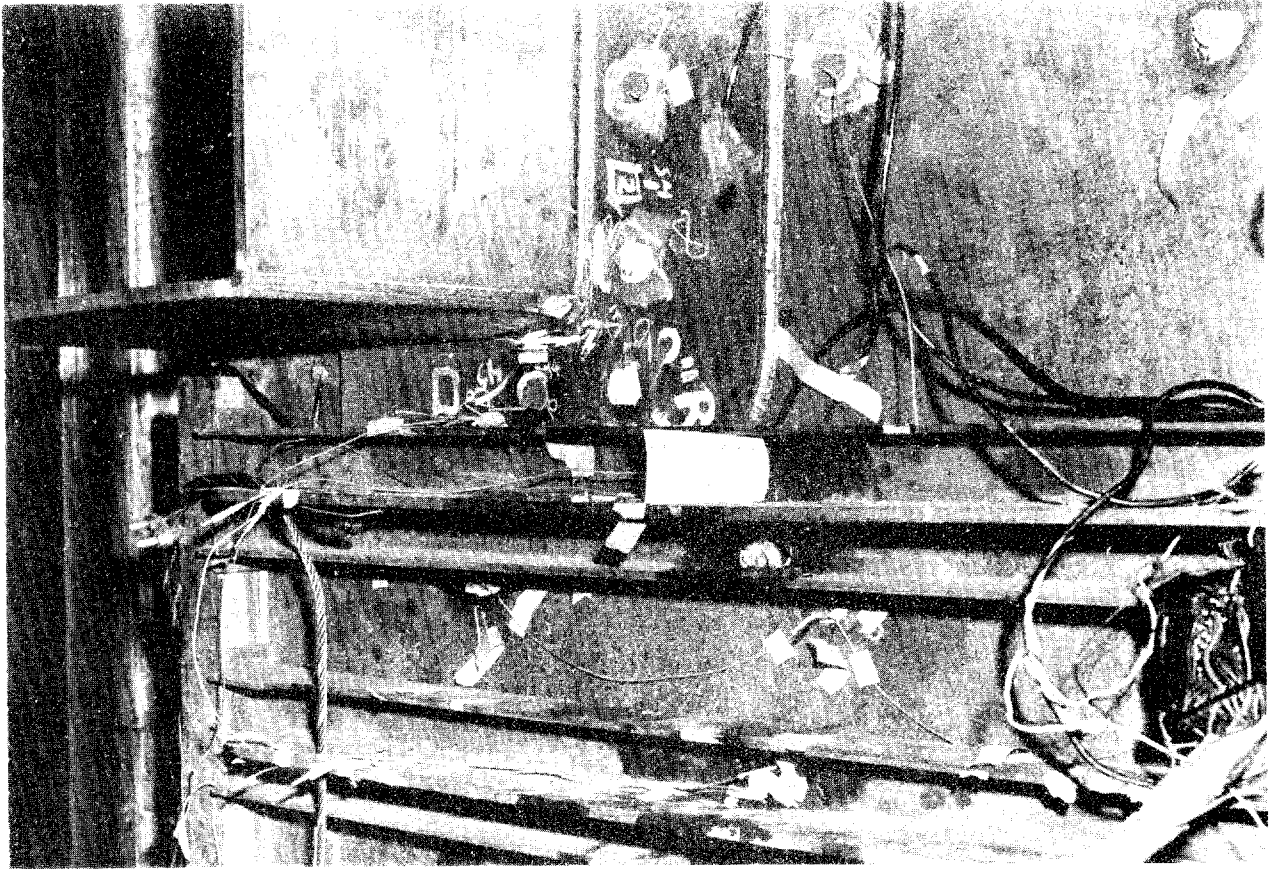
Fracture in doubler

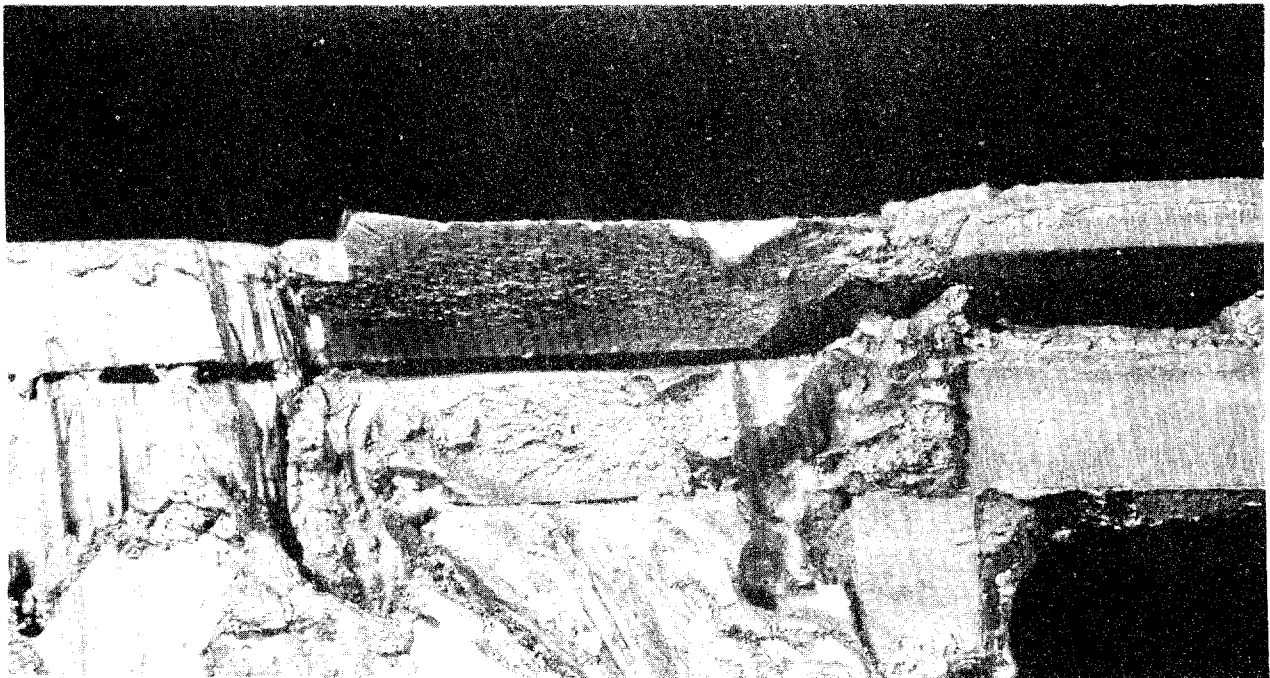
Deck and doubler fractures, looking fwd.
